Santos

Support Vessel Incident

Laceration To Head

Steve Furze, 5 March 2009

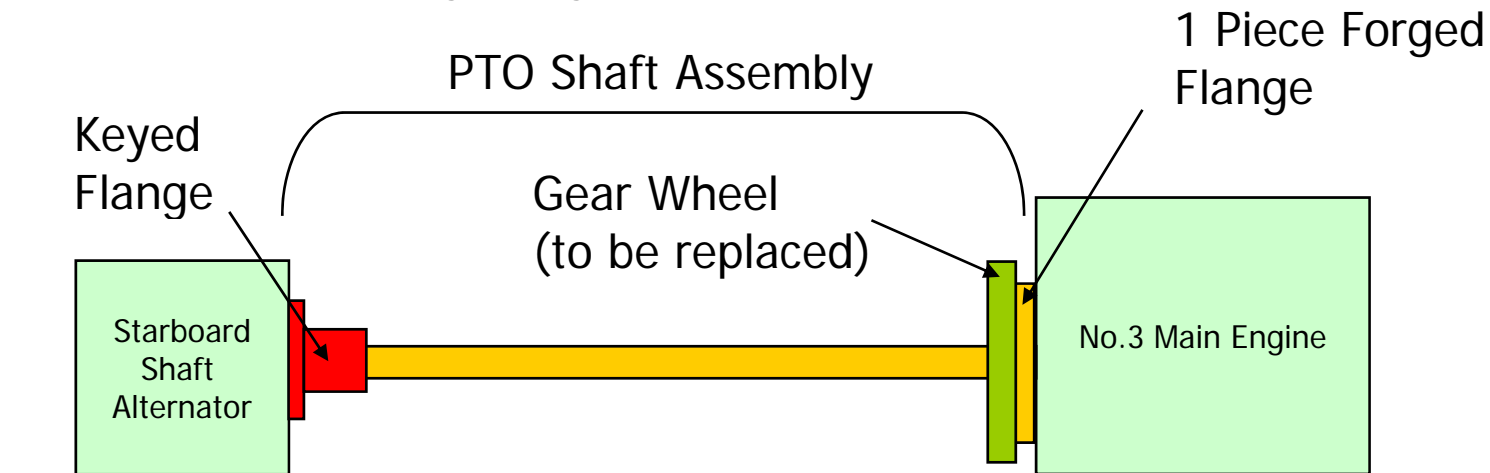
Power Take Off Shaft Arrangement

- Replace gear wheel drive for the No.3 Main Engine lubricating oil & fresh water pumps.
- Wheel is fitted to a Power Take Off (PTO) shaft positioned between the No.3 Main Engine and the starboard shaft alternator.
- Entire shaft assembly must be removed to replace the gear wheel.
- A keyed flange must be removed from one end of the shaft and re-installed after replacing the gear wheel.

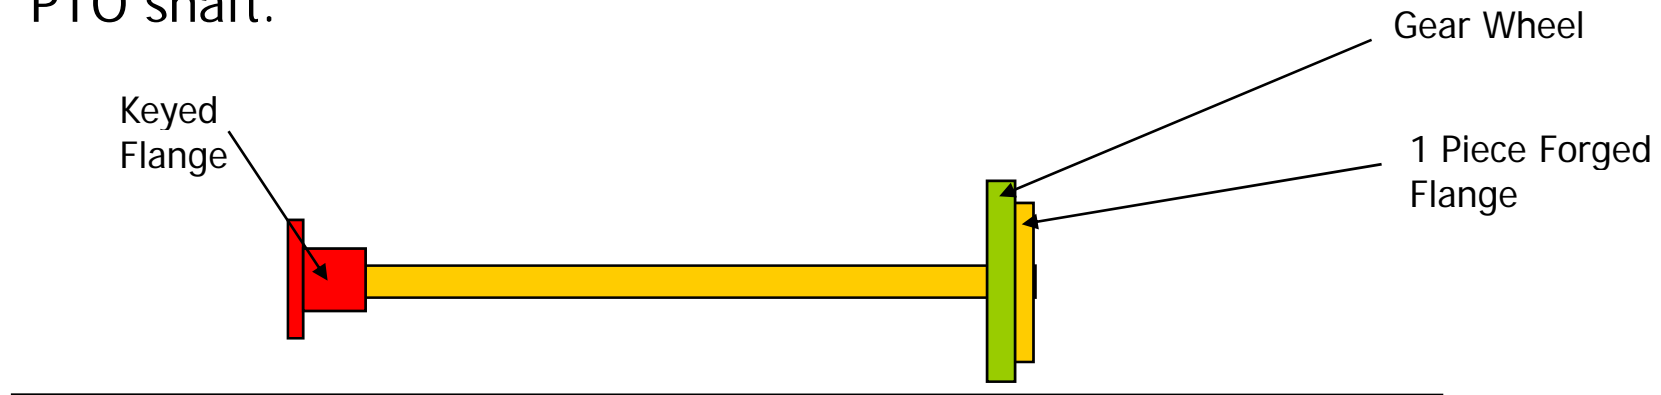
Keyed Flange Reassembly

- Tween deck beams
- 4"x4" RHS "Spacer"
- 30 ton- 10kg Hydraulic Jack
- 8" PTO Shaft Assembly
- Pneumatic Power Pack
- 4" x 8" Timbers

- Flange keyway alignment problems, flange was a tighter fit than expected.
- With flange ~40 mm from final position, jack pressure required began to increase rapidly to ~15 ton.
- Injured Person (IP) noticed engine room floor plates beginning to buckle.
- Bent down to bleed off the jack pressure at the pneumatic power pack.

- The jack scaped down
- The 4" RHS spacer section fell
- Struck the IP on the back of the head

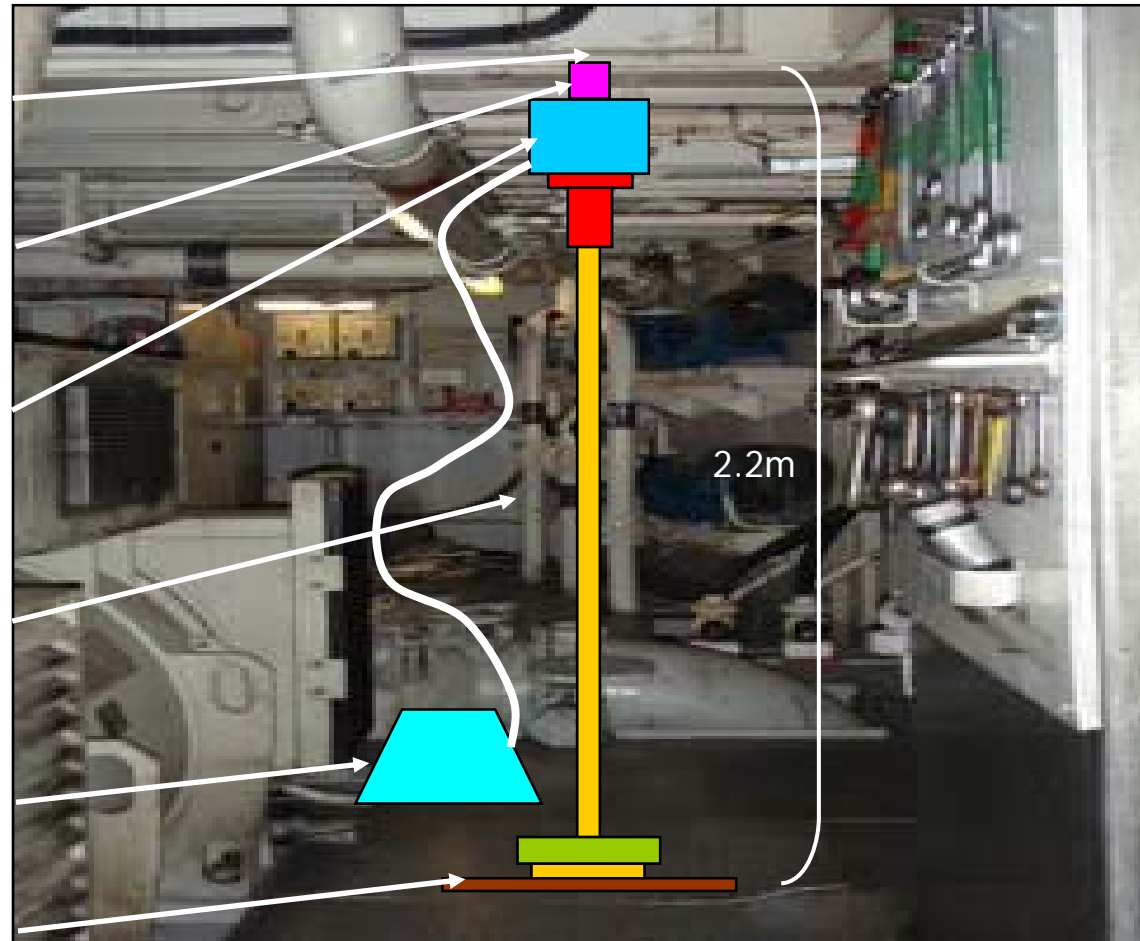
Shaft assembly was held vertical by 2 chain blocks

- No recognition of hazards involved.
 - Chain blocks not adequate for restraining PTO shaft while jacking vertically
- No PPE was worn during the task and this requirement was not recognised during the Toolbox Talk
- Initial incident investigation by vessel owner did not recognise the risk of inadequate horizontal restraint
 - Job was completed using very similar procedure – used stronger beams to jack against
 - Risks were still not reduced to alarp
