# Guideline Tensioner Incident

**Mike Ferguson**  
**Songa Mercur**  
**Operations Manager**

**DrillSafe Forum**  
**Perth Western Australia**  
**Perth 5<sup>th</sup> March 2009**

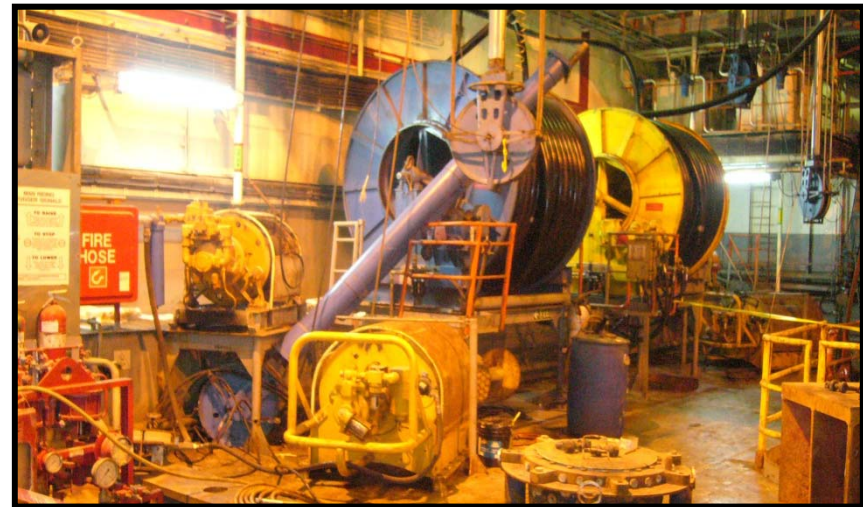
- No. 3 Guideline Tensioner Wire broke; and
- The Guideline Tensioner Assembly
  - broke its mounting bolts; &
  - fell to the moonpool deck.

The Guideline Tensioner assembly weighed approximately 1900 kgs

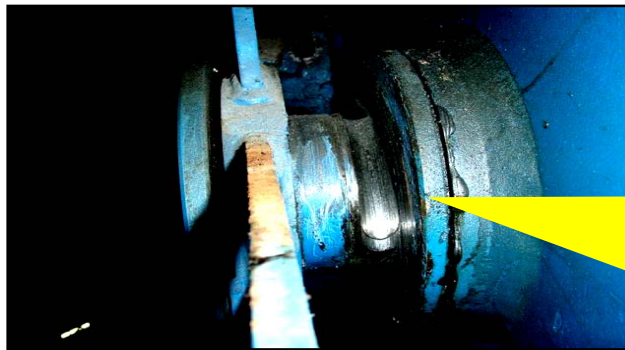
**1. The cable was not located on sheave correctly.**

The Guideline Tensioner wire jumped off the sheave and wore a groove on the bearing shaft

The diameter of the wire was  $\frac{3}{4}$  inch. The clearance between the jumper bars and the sheave was also  $\frac{3}{4}$  inch. This allowed the wire to slip into the space between jumper bars/sheave.

**Design gap too large**

- Relocate jumper bars to close the clearance between sheave and jumper bar
- Fit drops protection on the Guideline Tensioner
- Notify all Songa rigs of incident
- Check all guideline tensioners across the fleet

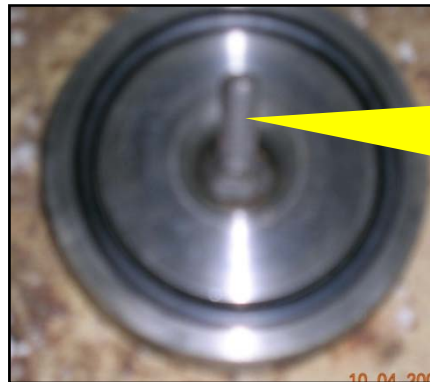
**2. A foreign object (bolt) caused a hydraulic lock within the Guideline Tensioner piston.**

A bolt lodged in the orifice plate preventing the hydraulic fluid passing through the orifice

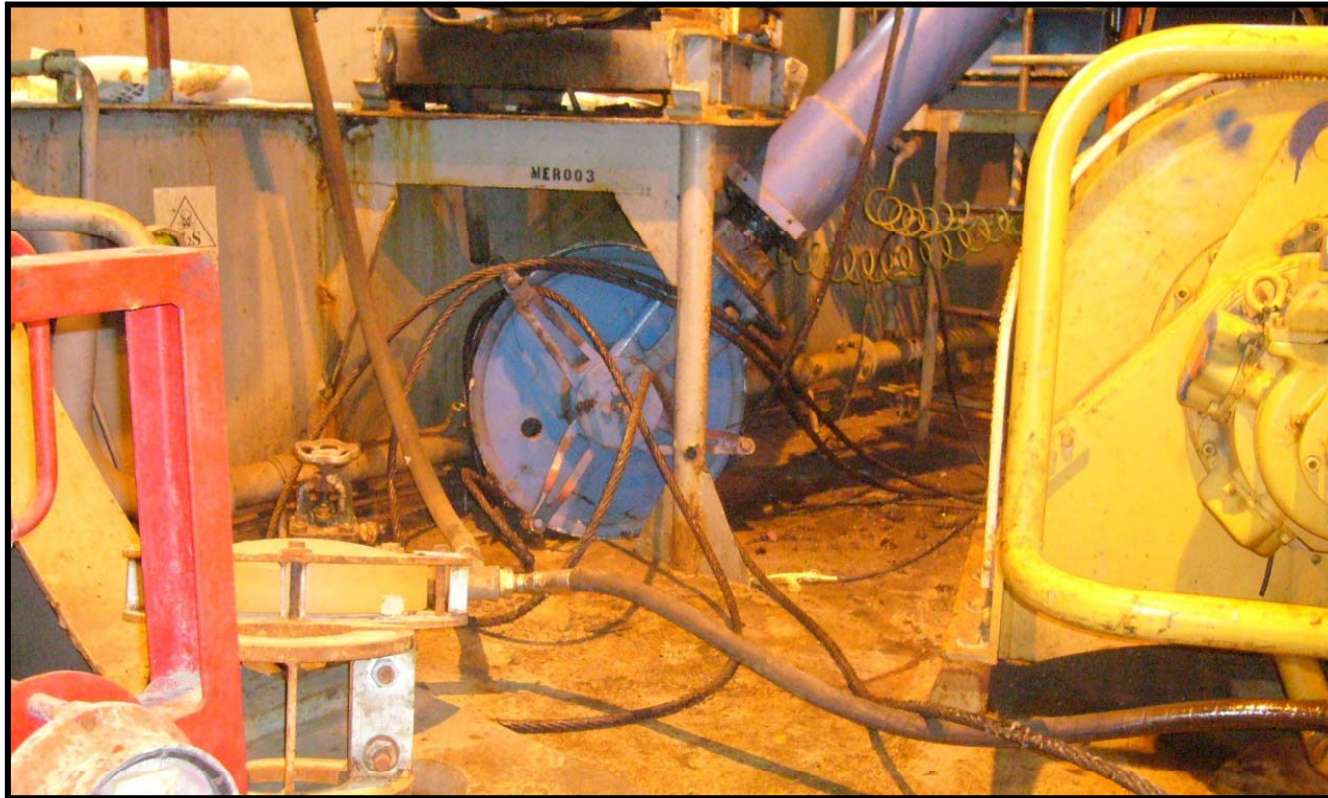
- When the Guideline Tensioner Wire broke, it released the tension on the wire, causing the piston to extend rapidly.
- During this rapid extension, a foreign object within the cylinder oil orifice caused a hydraulic lock.
- The resulting shock load was transferred to the base plate bolts causing the:
  - bolts to shear; and
  - Guideline Piston Assembly to fall approximately 3 metres onto Moonpool deck.
- The lower sheave of the piston assembly slid underneath the air tugger winch & the upper end of the piston came to rest on the BOP umbilical cord reel.

**The Guideline Tensioner after the fall**
