# JACK RYAN

## Tree handling incident

### Short presentation

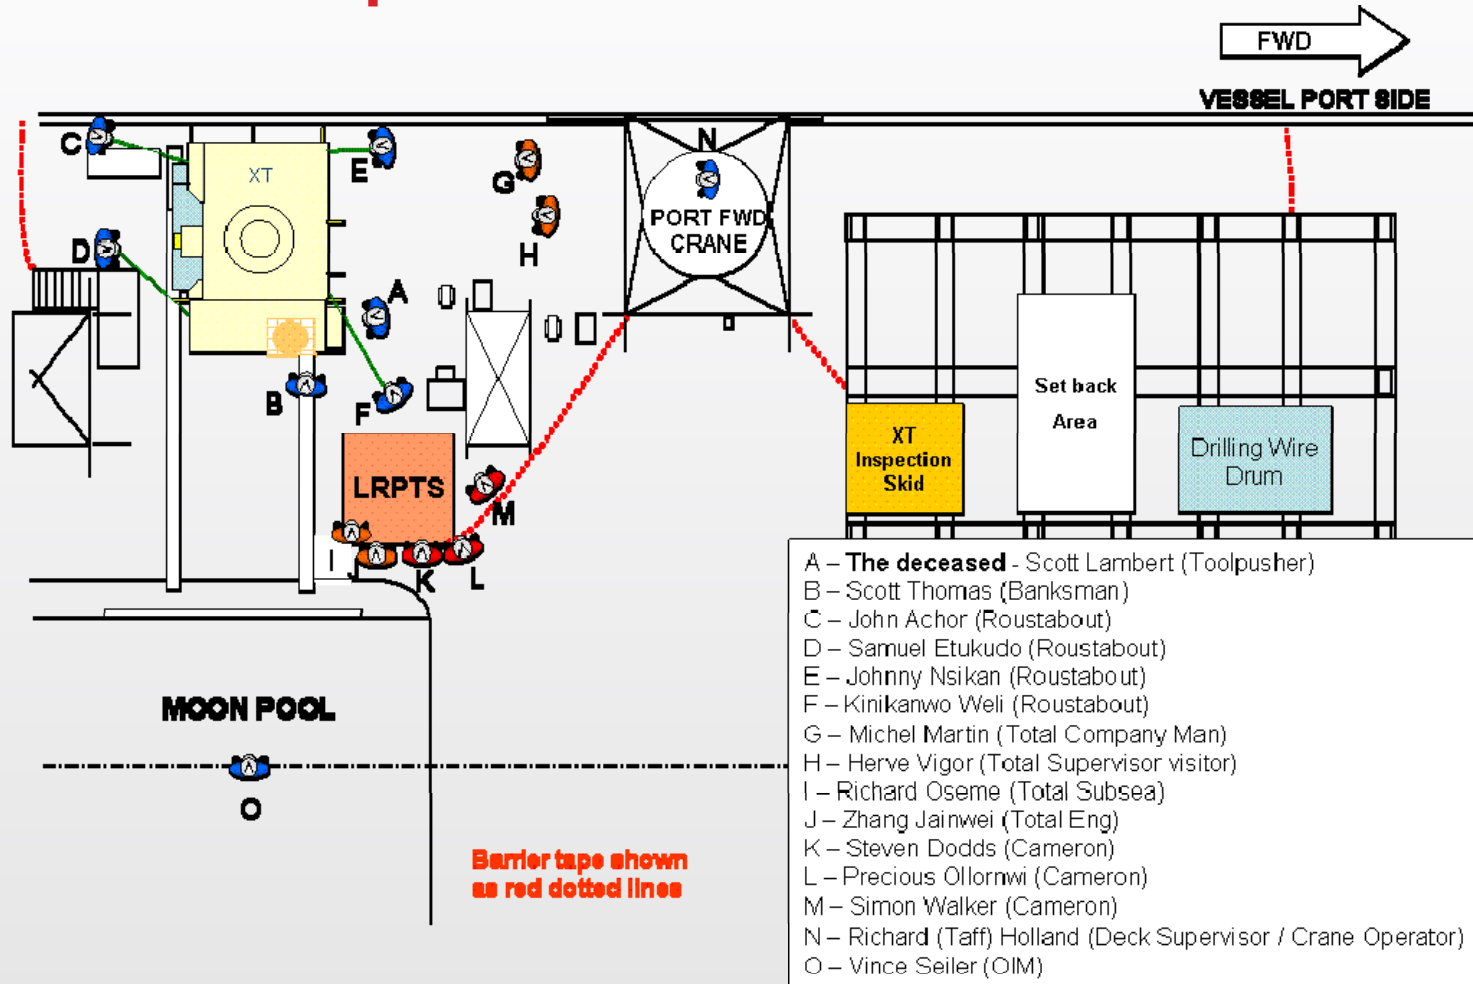
## Position of People at time of the incident

- The tree was picked up approximately 2 ft above the XT trolley to clear the guides, and was held stationary while minor boom and slew adjustments were made by the Crane Operator.
- As the Crane Operator engaged the control to lower the load, the tree was observed to free-fall and landed misaligned on the XT trolley.
- The tea cosy was observed to “pop up” from its pedestal, deflect off the tree and tumble to the deck, striking Scott Lambert and knocking him to the deck.

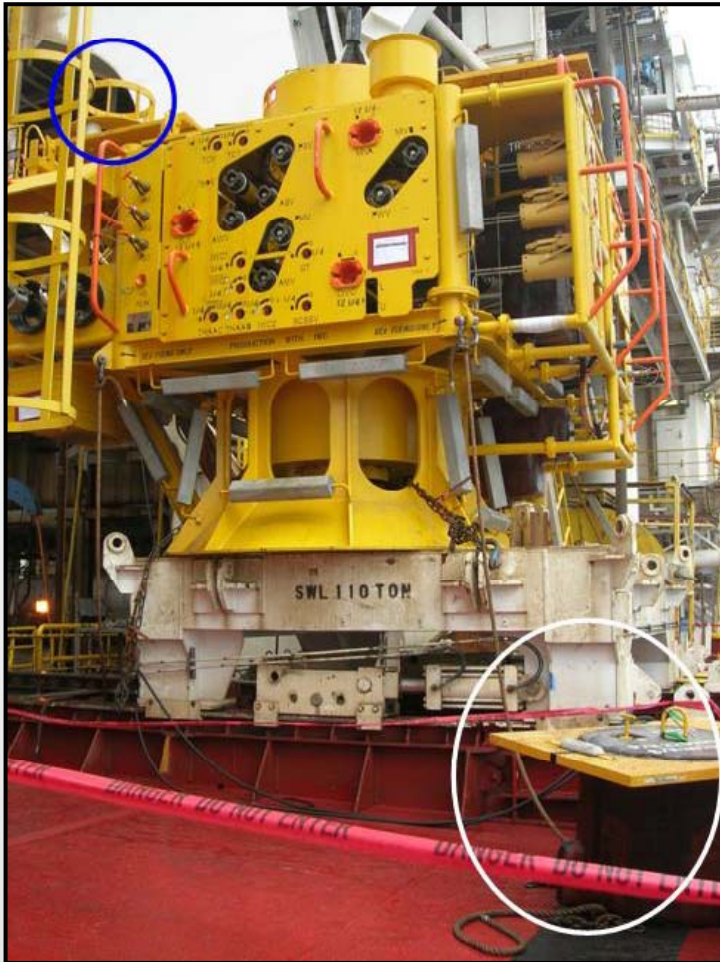
- The **tree** is also fitted with the following items, which are not a permanent feature of the tree: Seal kit (VX gasket) in wooden box, Tree cap in parking position on tree top plate, CHC Debris Cap, REH Tea Cosy (one which fell) on pedestal, Choke Tea Cosy ,Tree lift cap and sling assembly. **DO I MAKE DROP OBJECTS AS A BIG DEAL ON MY RIG?**

Tree #7 on XT Trolley

Blue circle  
- Tea Cosy pedestal

White circle  
- Tea Cosy final position

- › Prepare TSTP for this operation in conjunction with Total & Third Party (subsea tree owners) for lifting the tree to the rig and around the rig.
- › Use of lifting checklist prior to any tree movements : Ensure all items identified as potential dropped objects are secured in a manner approved by Total and the tree supplier engineering department.

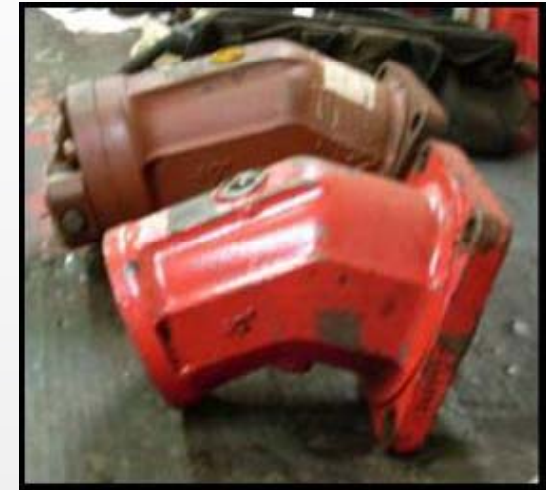
- An interchangeable **motor** undersized for the application, had been fitted to the main hoist winch on 29 Sept 08. The motor mounting plates and drive shafts on both models are the same, therefore allowing an interchangeable motor and undersized for the application to be installed on the main hoist winch drum. Note: The SEATRAX **crane** Manual was onboard but not used by the Mechanic to reference the correct part number for the main hoist winch. **AM I ALWAYS USING THE CORRECT TOOL FOR THE JOB?**

TC 2006 Motor Behind  
TC 2010 Motor

- › Inspect all 4 cranes and verify that the correct motors are fitted as per the manufacturer manual and / or Manufacturer latest documentation
- › Verify personnel have access to the Manufactures Manual which provides the appropriate and current technical details of crane motors / Part Number / Model Types. This must include that the suitable motors to be fitted to the various applications.

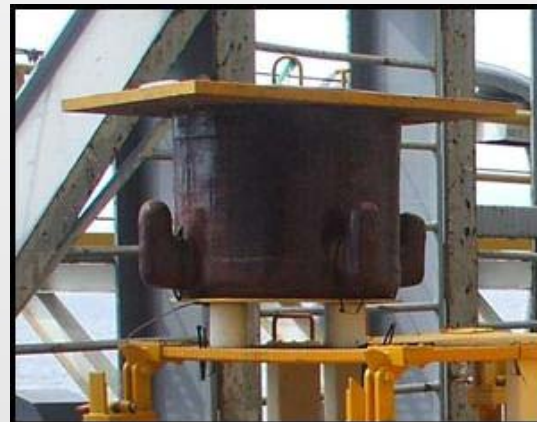
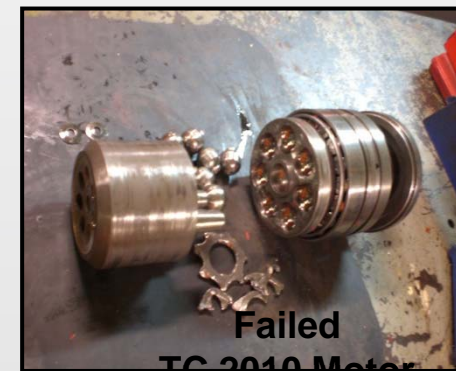
- This **motor** had been sourced from the Mechanic's workshop. It was not new, and furthermore, its usage and history is unknown. **DOES THIS FEEL LIKE THE CORRECT WAY OF MANAGING PARTS?**

Failed  
TC 2010 Motor
