Repeating a High Potential Incident

James Peyton
March 2013

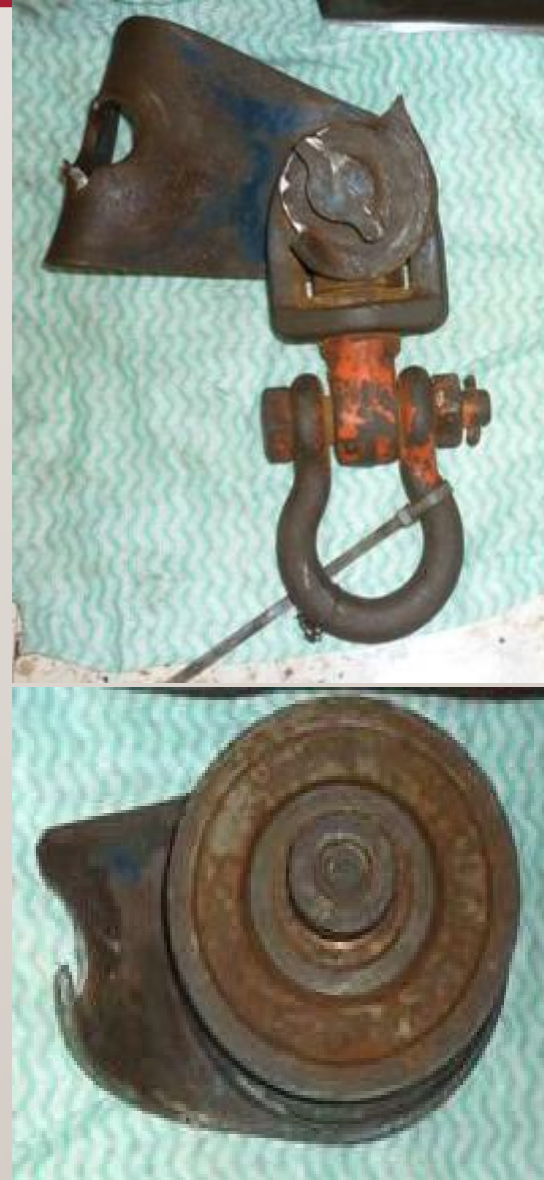
High Potential Incident #1

- § Pumping cement for open-hole abandonment plug
- § Rotating at 50 RPM
- § After 7mins, swivel seized suddenly
- § Cement hose wraps around cement head
- § Sheave on tigger line torn apart and found on pipe deck 33 metres from drill floor
- § No one hurt

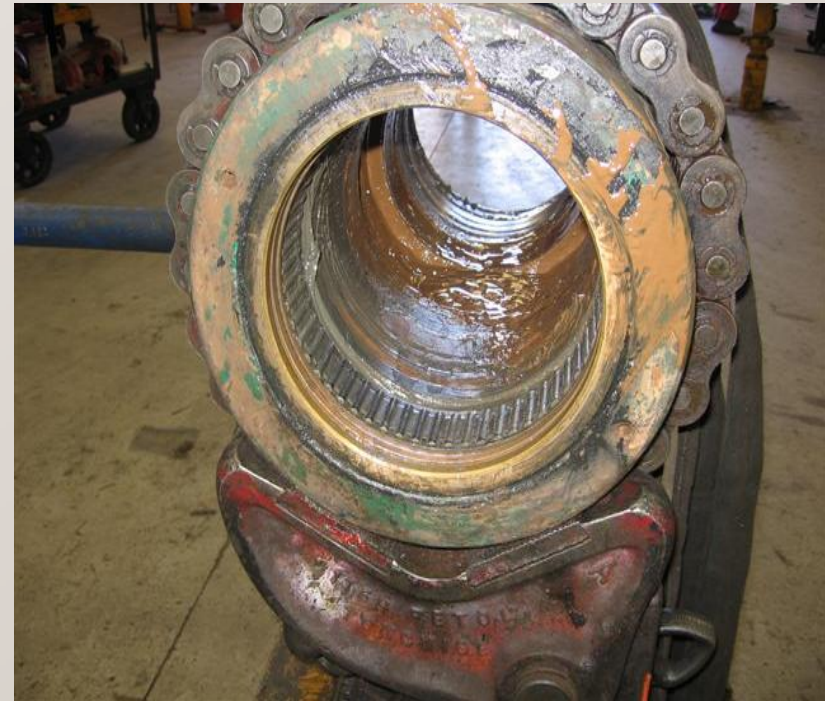
Investigation #1

- § Investigation team sent to rig
- § Cement head was rotated above limit (20 RPM)
- § A single guideline was used to hold swivel stationary (2 recommended)
- § Swivel stripped down - no damage identified
- § Swivel rotated freely in workshop
- § No definitive root cause of the failure identified

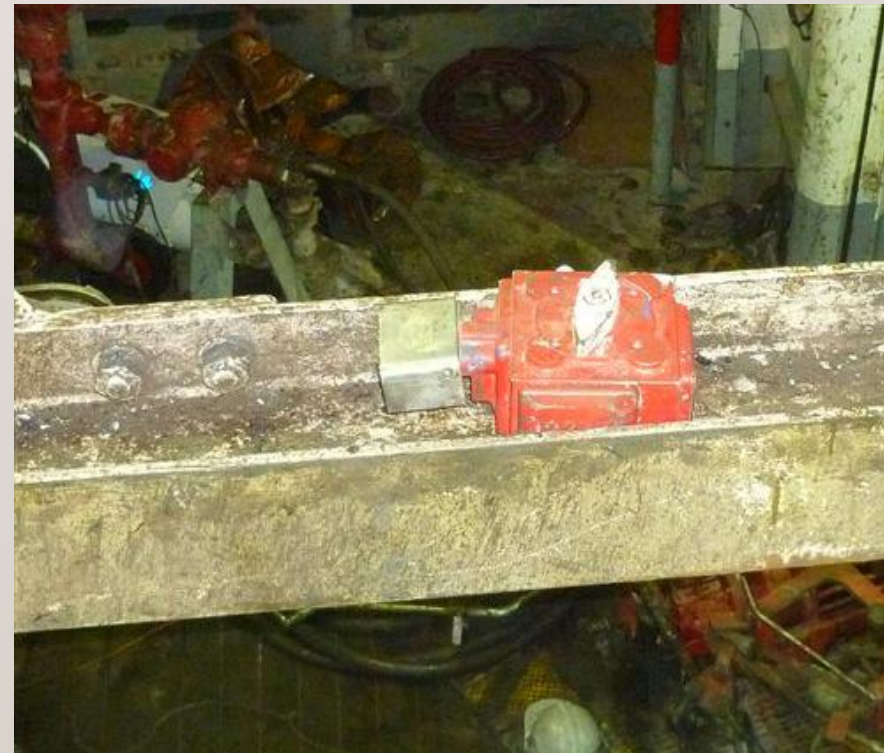
Incident #2

- § Cement head rigged up with 2 guidelines
- § Rotating the liner at 12 RPM whilst circulating prior to cement job
- § Swivel section of the cement head assembly locked up
- § Cement hose, control lines and tigger lines turned and came into contact with guidelines
- § The lo-torq actuator, weighing approx 8kg, was ripped off and dropped from a height of 9.5m above the drill floor to rest in a girder 5.5m above the drill floor
- § No one hurt

Note – swivel was a different S/N to previous incident

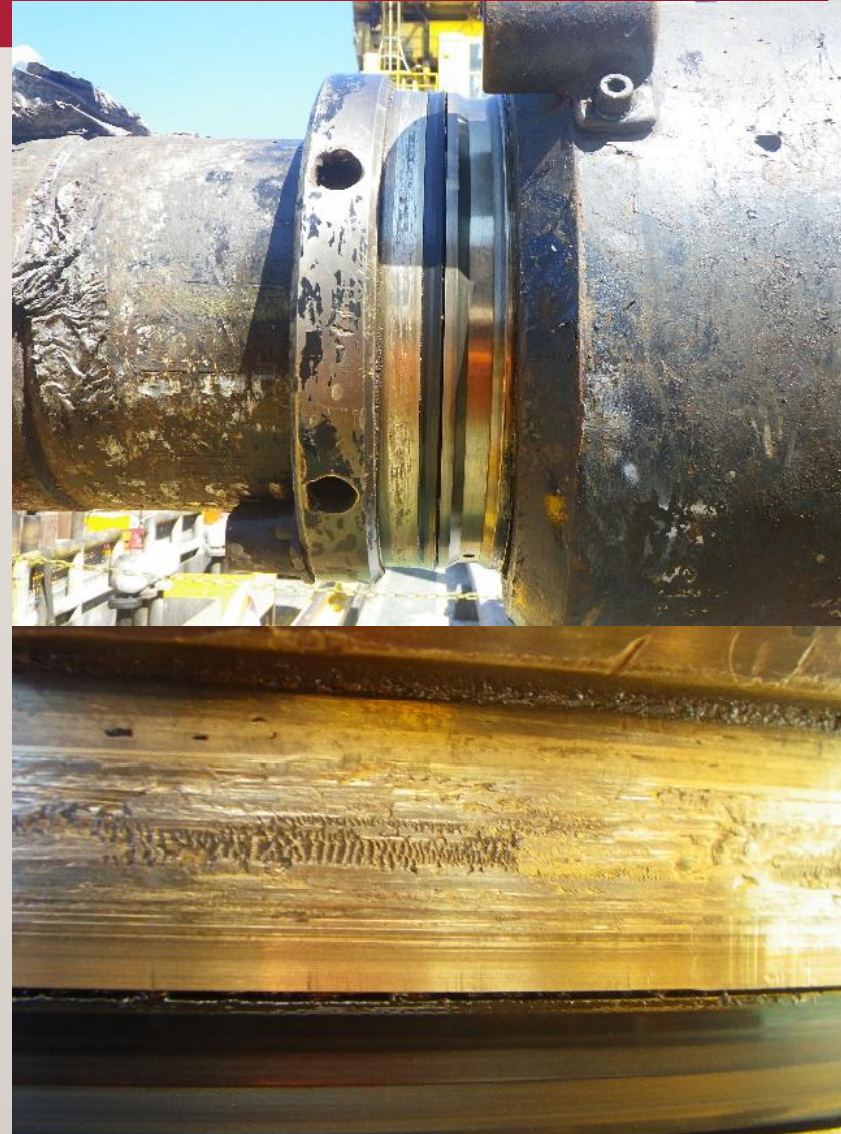
Galling on Air Bushing

- § Repeat incident
- § Investigation team mobilised to rig
- § All measures implemented from previous investigation were in place
- § Initial investigation focussed on visible galling on swivel air bushing
- § Air bushing is a third-party modification and not documented in maintenance procedures
- § Recommended improvements to procedures to capture changes to tools

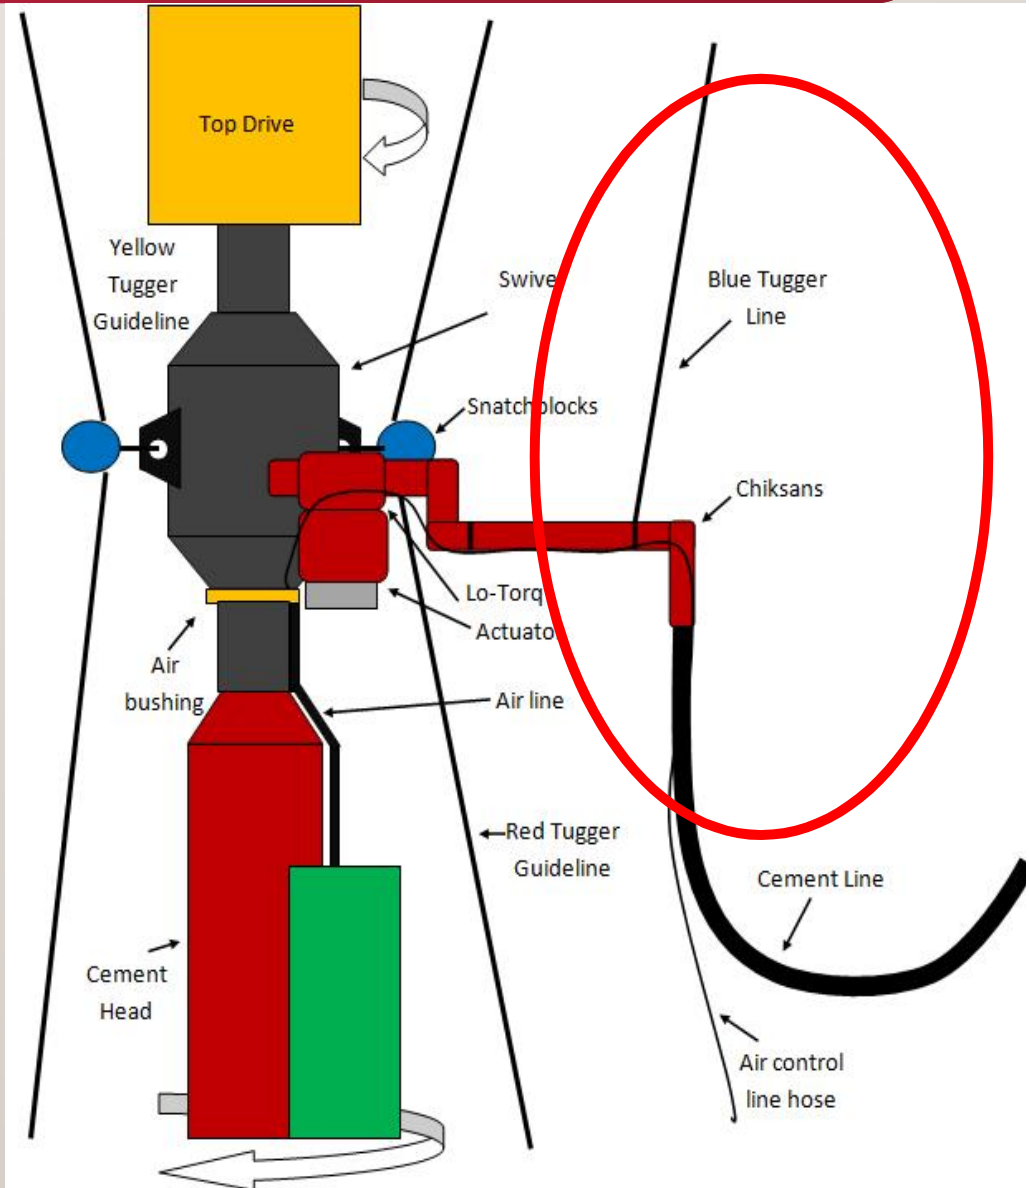
Rig Up

- § Cement line must be supported to remove load on connection
- § Recommended rig-up for cement head does not cover how cement line is supported
- § Multiple methods
- § Recommended procedure be reviewed for entire system

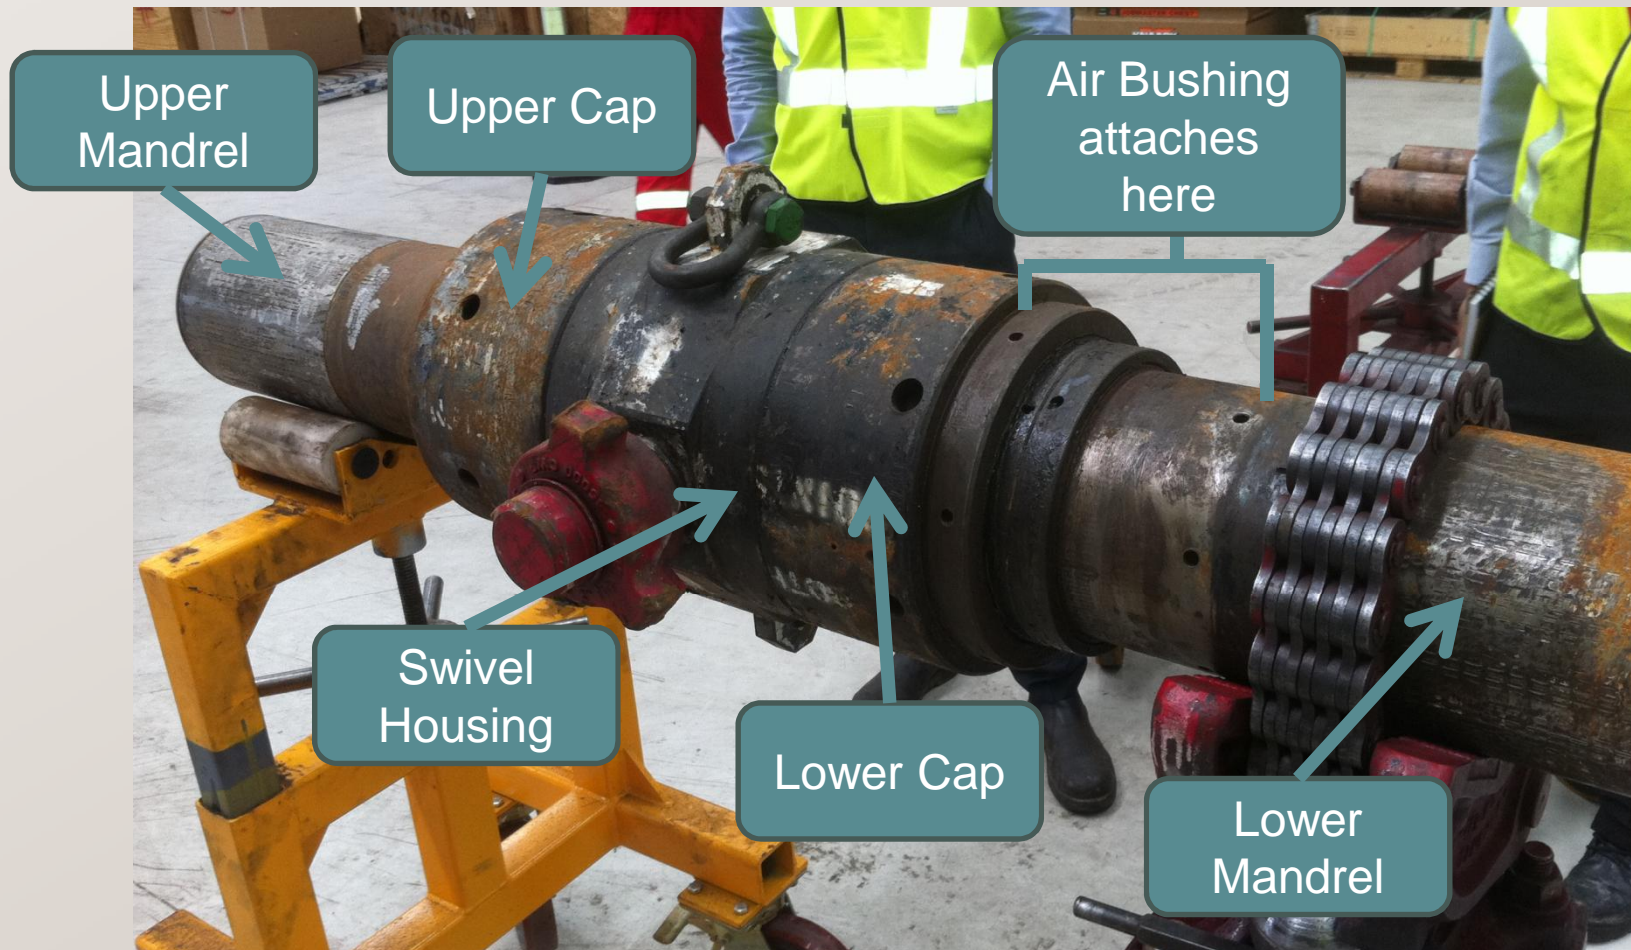
Testing the Swivel

- § The damaged air bushing was made up to the swivel
- § The swivel could still be freely rotated

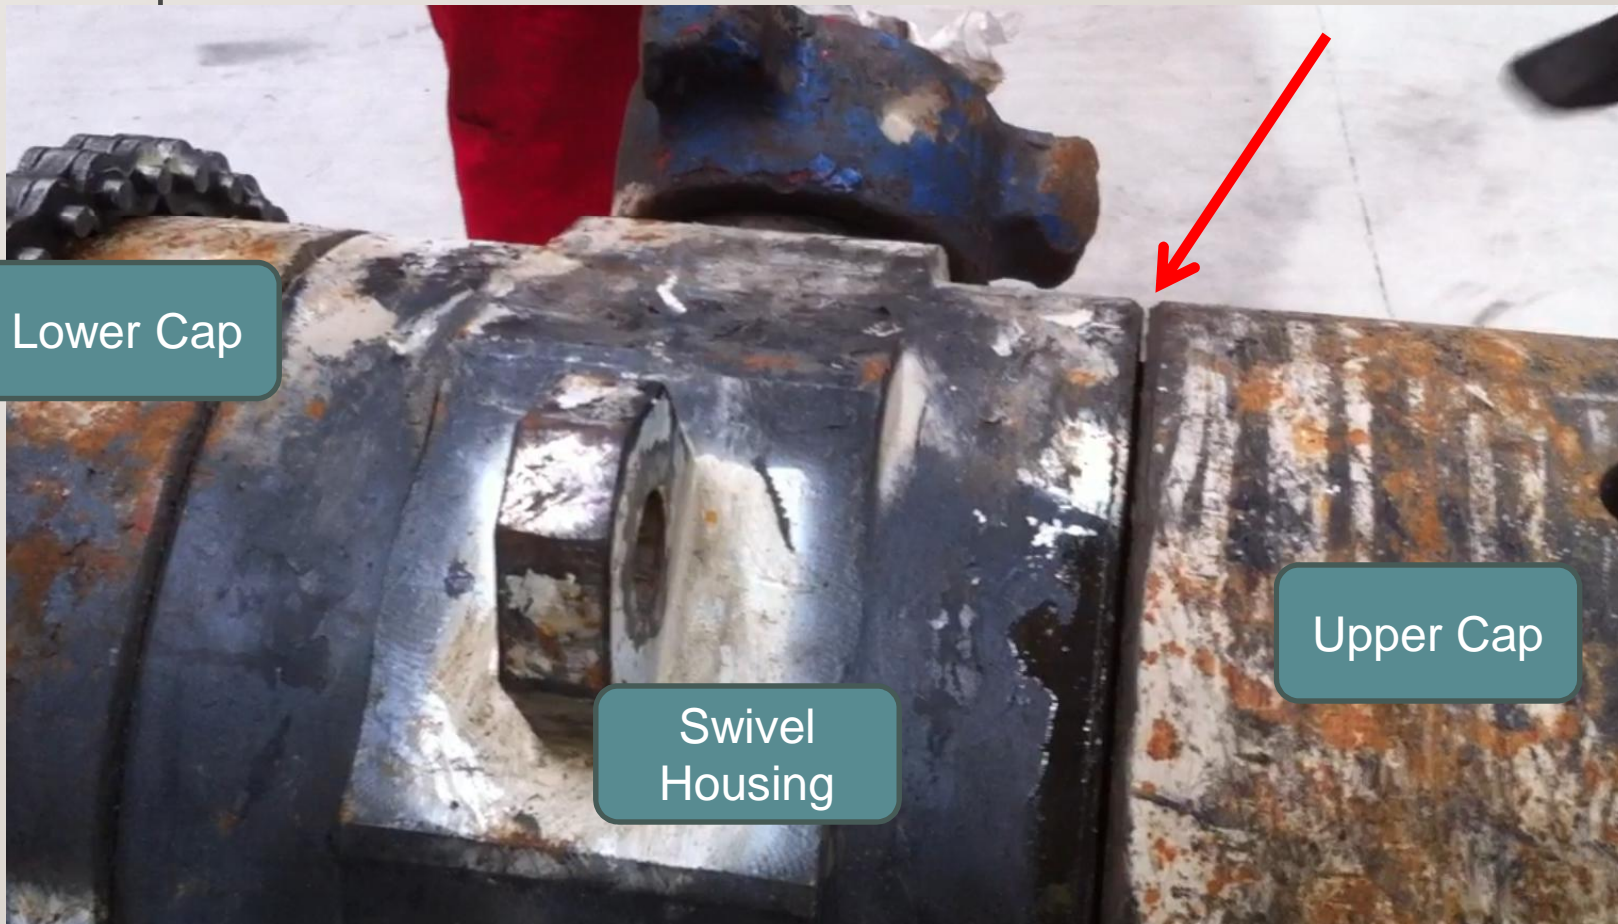
Discovering the Root Cause

- § Due to chance encounter with technician
- § The upper cap was backed off a few millimetres and the swivel completely locked up

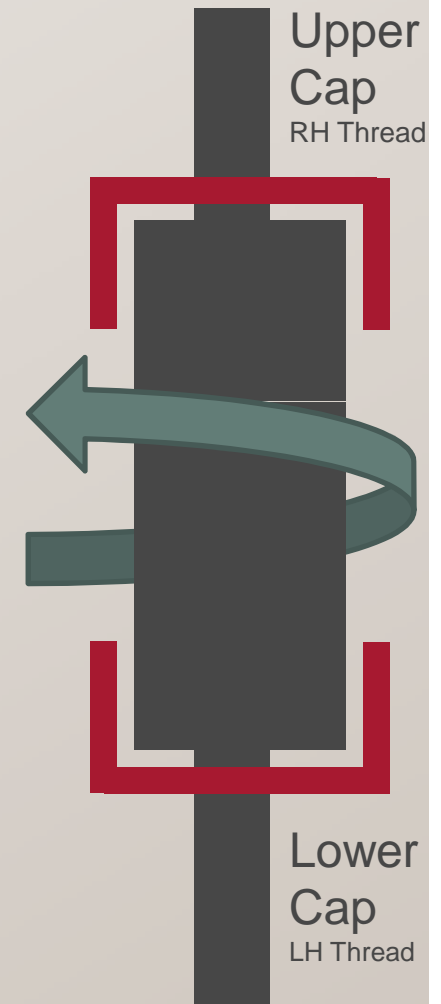
Swivel Caps

- § It was discovered a similar problem had been seen before and corrected
- § The LOWER cap had been observed to back off when rotating causing the swivel to seize up
- § This was due to RH rotation backing of the upside down RH thread on the lower cap
- § The direction of the thread on the LOWER cap was reversed to prevent this issue occurring (RH thread changed to LH thread)
- § The swivel involved in the incident had this modification
- § Conclusion: the caps can be caused to back off due to backlash during RH rotation
