Riser Connection Incident

A Wroth

Perth March, 2014

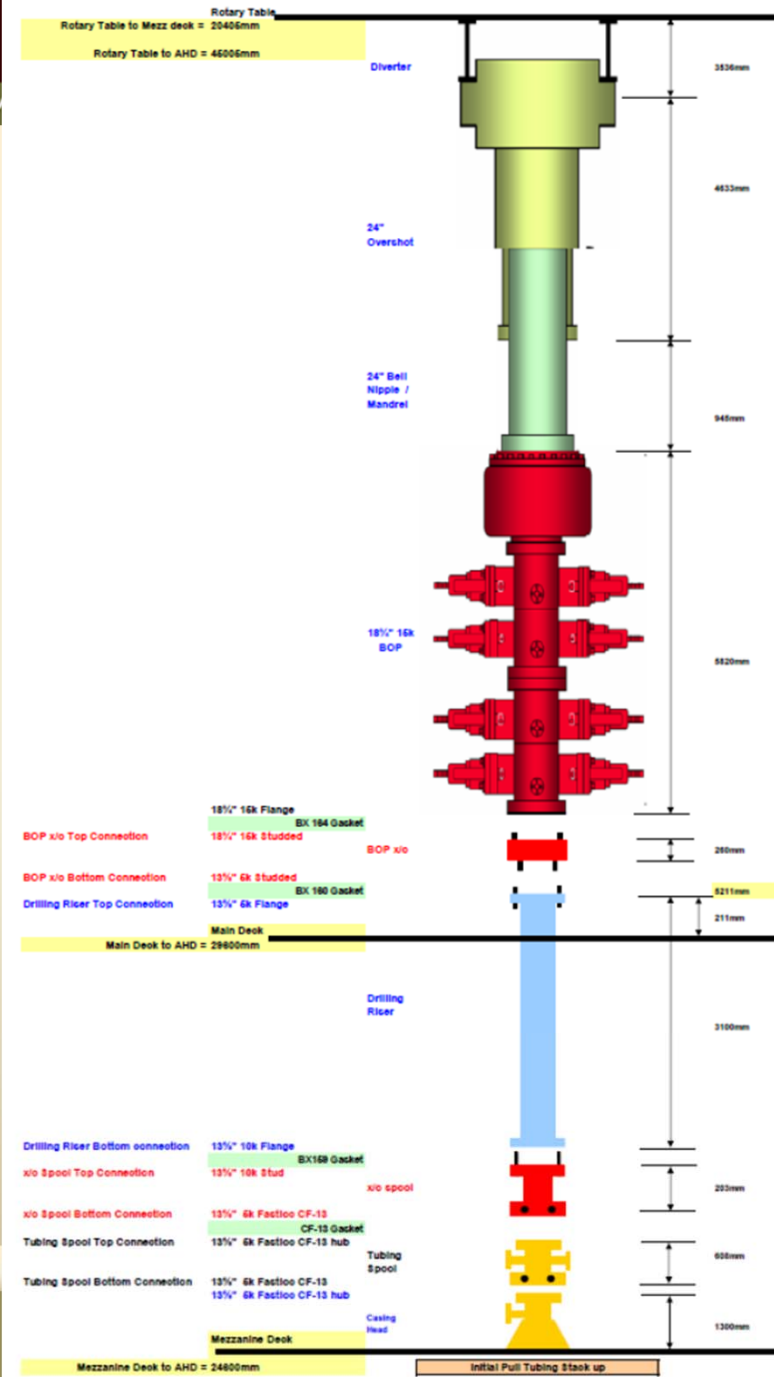
Toolpusher and Completion Supervisor taking some space out measurements around the wellhead and noticed that a number of the nuts on the 10K 13 5/8” API flange were loose

Stopped drilling, circulated while torquing up - 12 of the 20 bolts were free to turn, the remainder were tighter, but not torqued up.

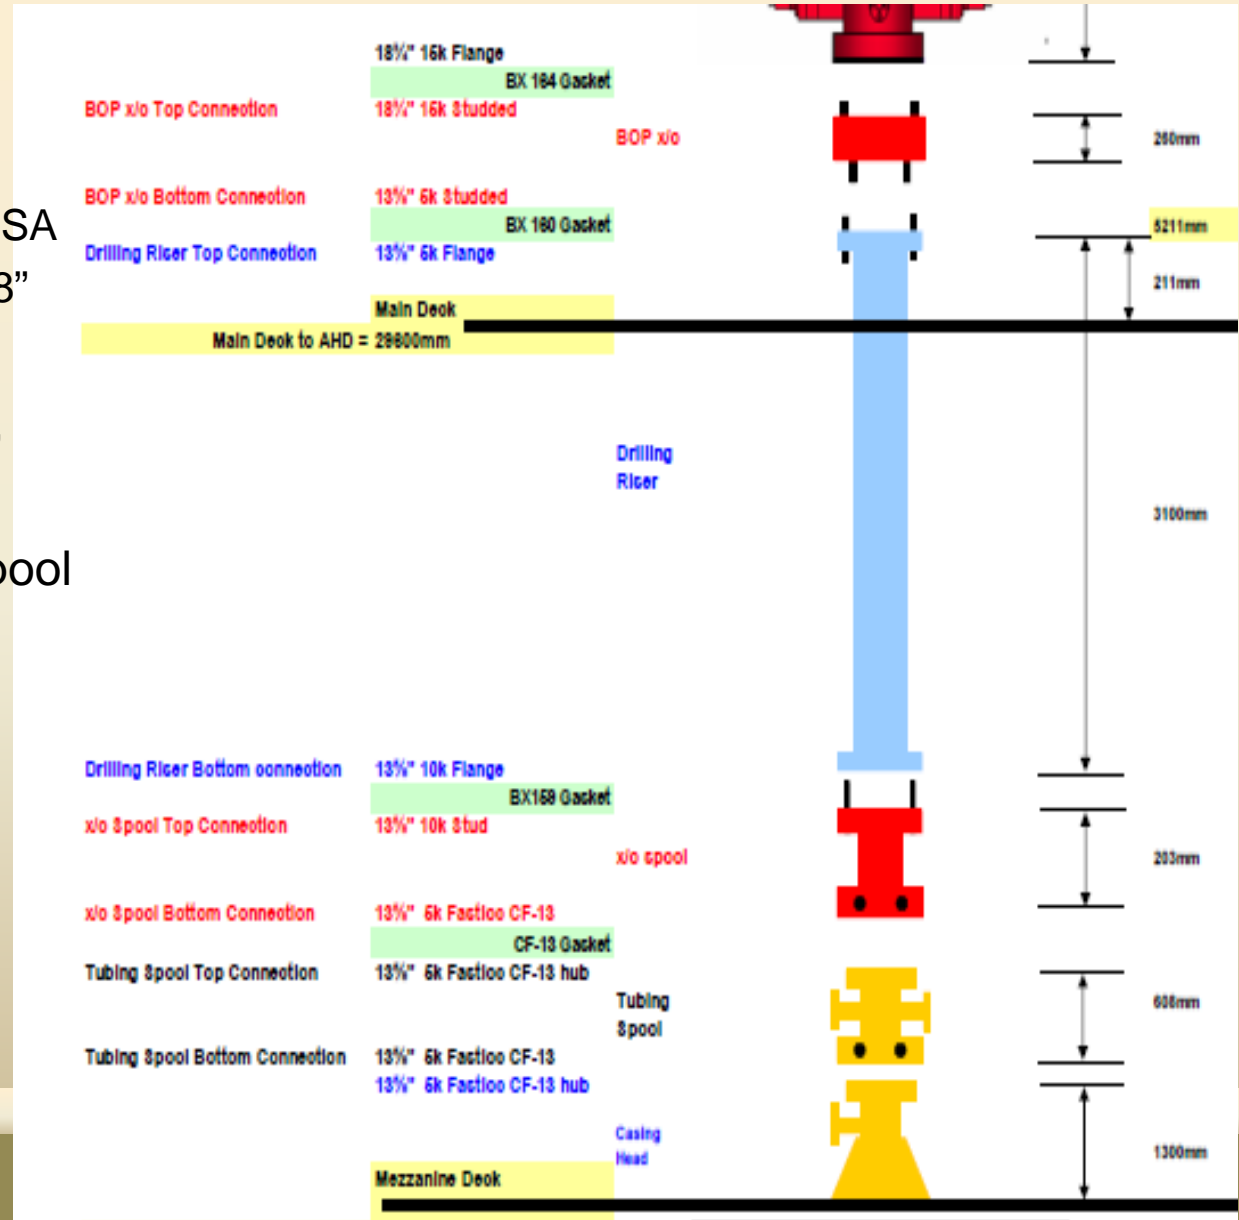
Equipment Involved

BOP – 18 3/4" Schaeffer

Riser assembly comprised

- 13 5/8" 5k x 18 3/4" 15k DSA
- 13 5/8" 5k flange x 13 5/8" 10k flange 3.1m long HP riser
- Cameron CF13 x 13 5/8" 10k flange XO

5k 13 5/8" Cameron tubing spool
