CaCl₂ Brine Incident

#2313

M-I SWACO Broome
Western Australia

CaCl₂ Brine Incident #2313 Summary

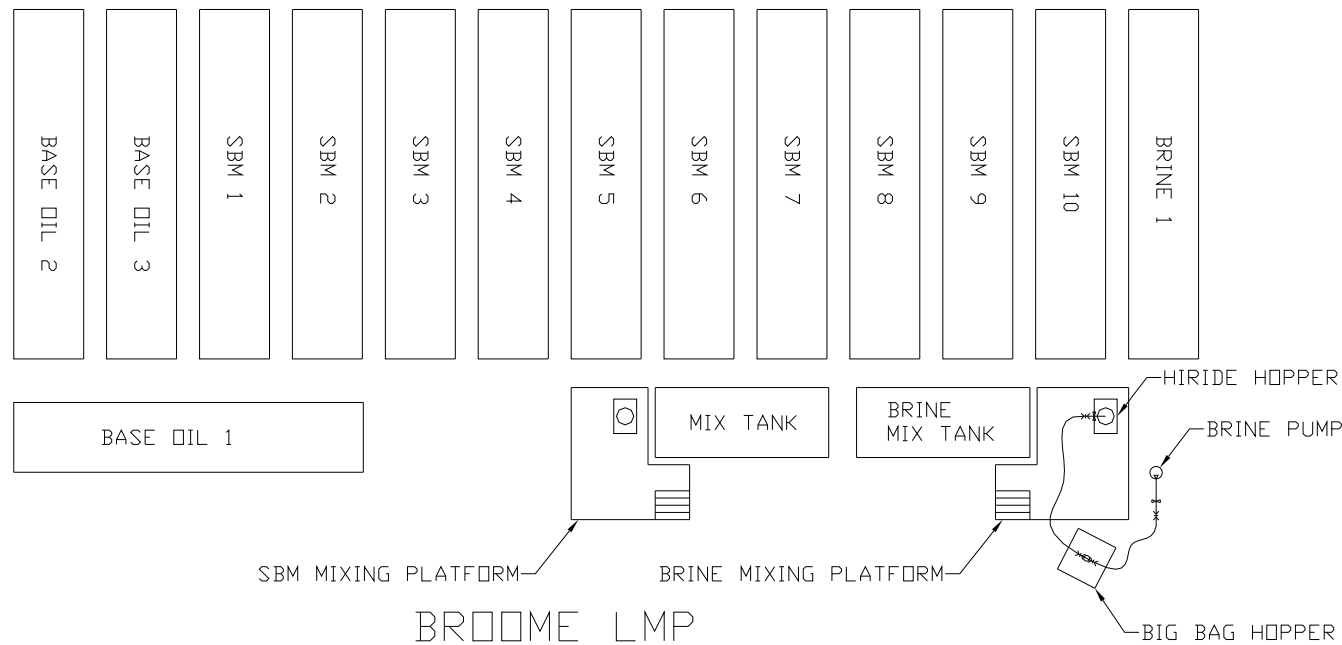
- The BBH was located on the concrete loading bay in front of the Brine mixing platform with the BBH outlet approximately 5m from and 0.5m below the inlet connection on the base of the 'HIRIDE Hopper' (HRH).
