NOR Offshore Ltd.

SERIOUS LEG INJURY ONBOARD NOR SUPPORTER

INCIDENT OVERVIEW - 21st of June 2007 @ 0730hrs

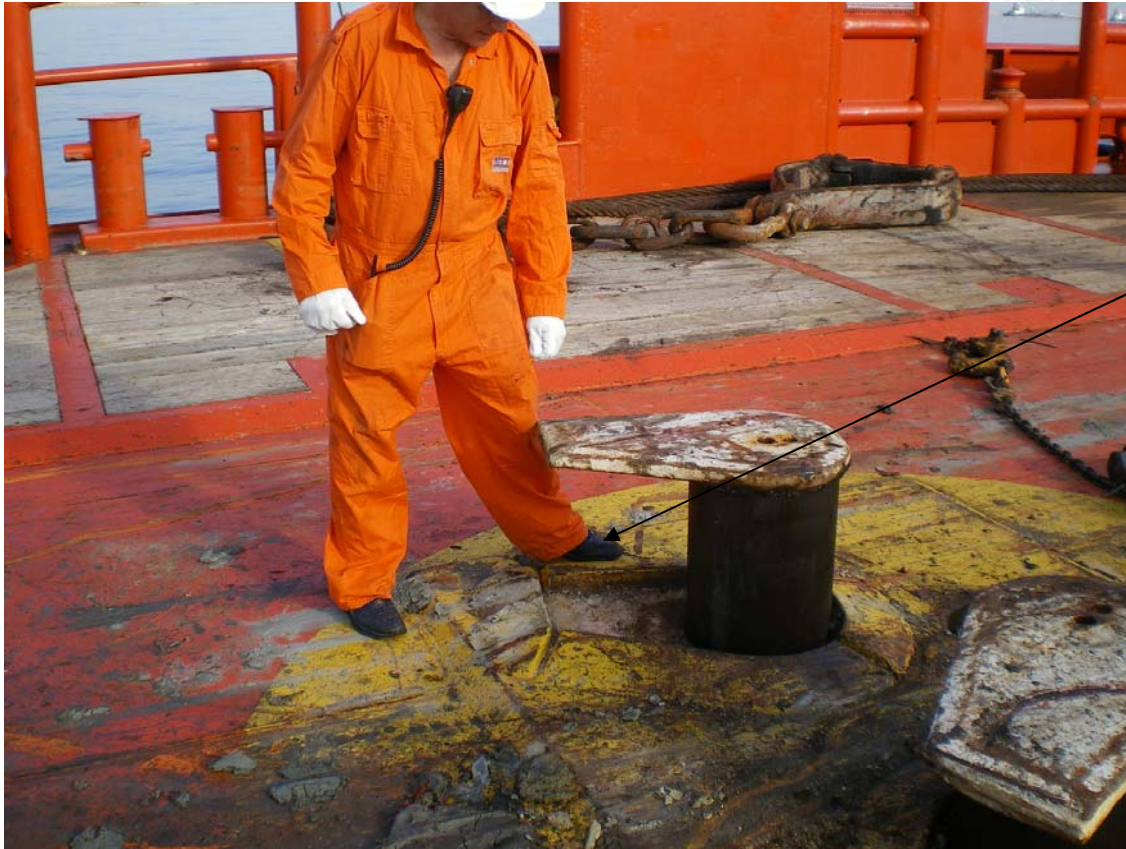
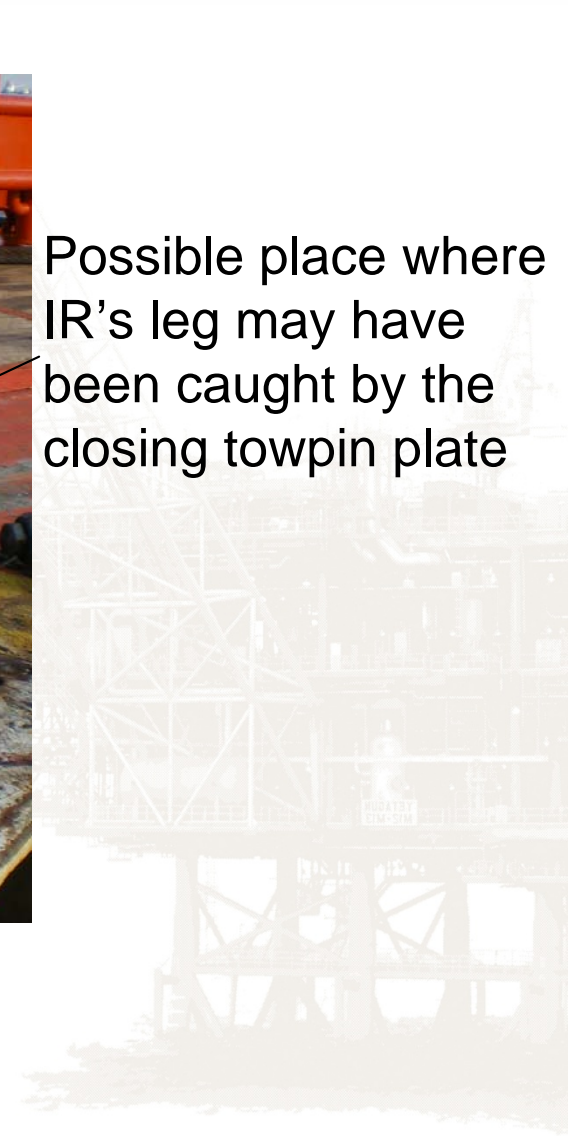
Possible place where IR's leg may have been caught by the closing towpin plate

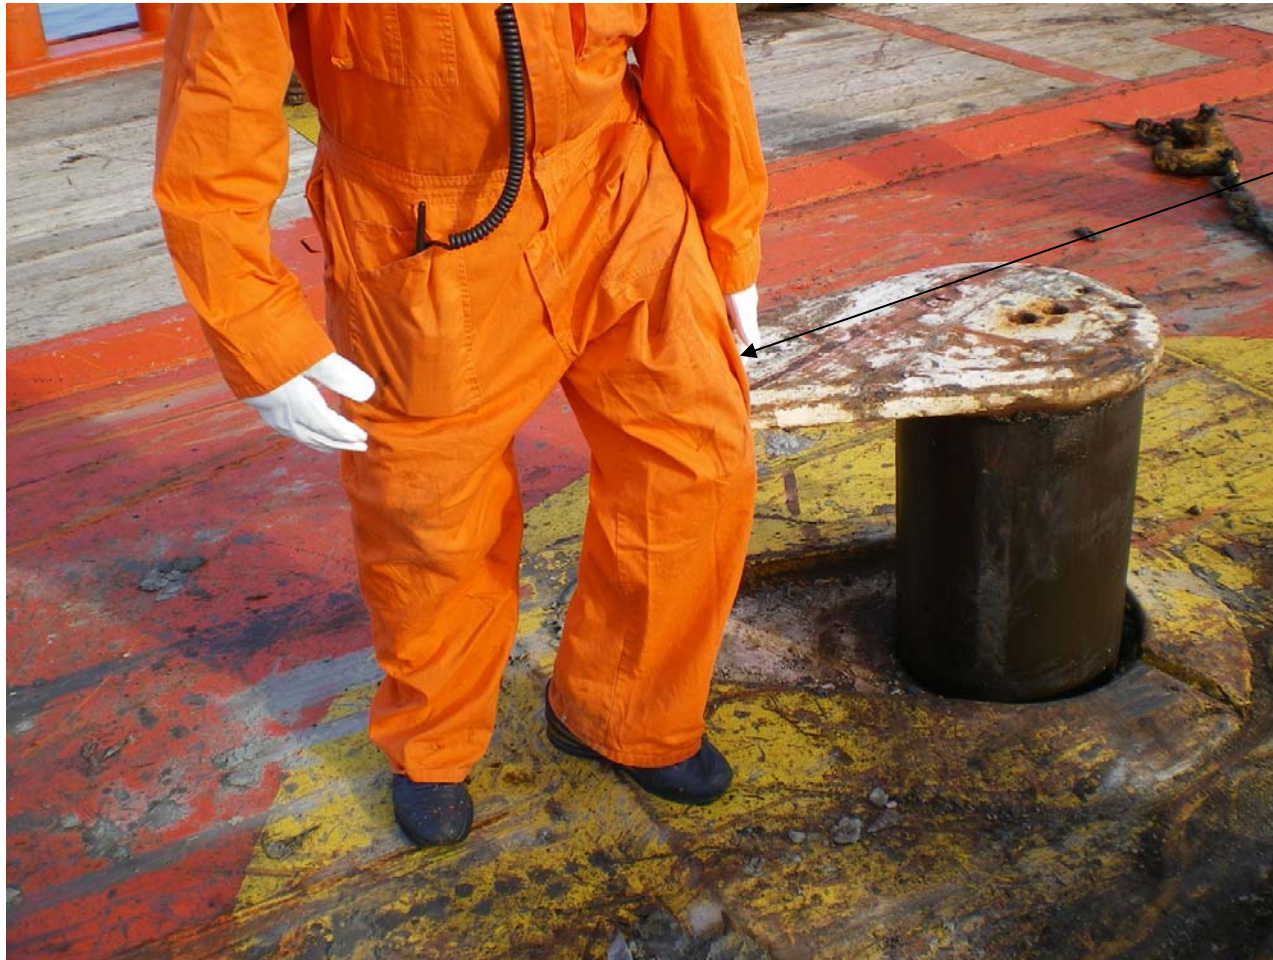
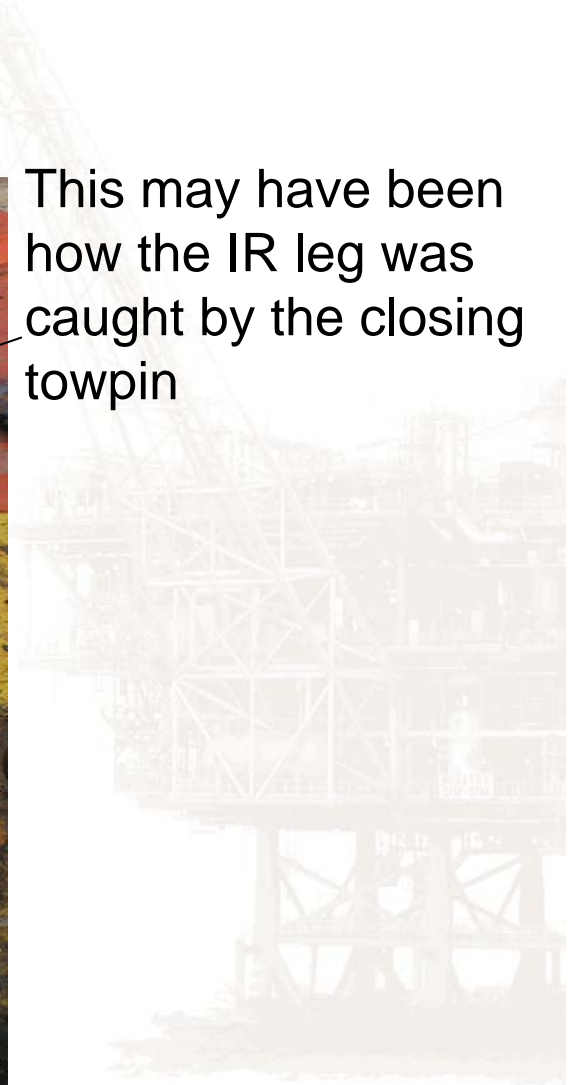
This may have been how the IR leg was caught by the closing towpin

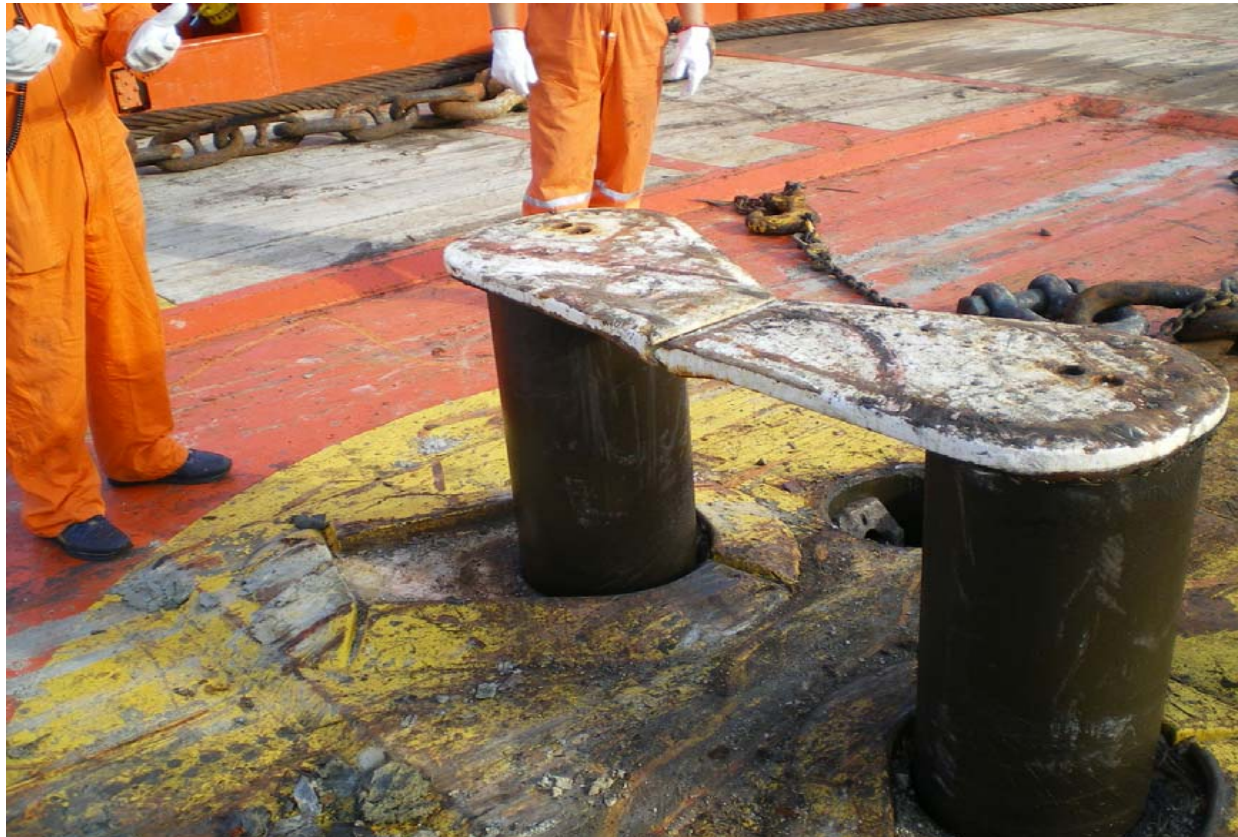
The Towpin fully locked

- The management has agreed to install an alarm system to alert the Crew members working in the vicinity of the tow pin. Instruction placed on bridge to raise tow pins individually.

- Tow pin area painted in safety colors, highlighting hazardous zone
- During Multi Tasking, The Master or any responsible officer shall ensure that such operations must be carried out safely with due regards to the criticalness of each task that are being performed.
