TDC 01 – BOP Toppling

TDC 01 – BOP Toppling CSG Cavitation Stack

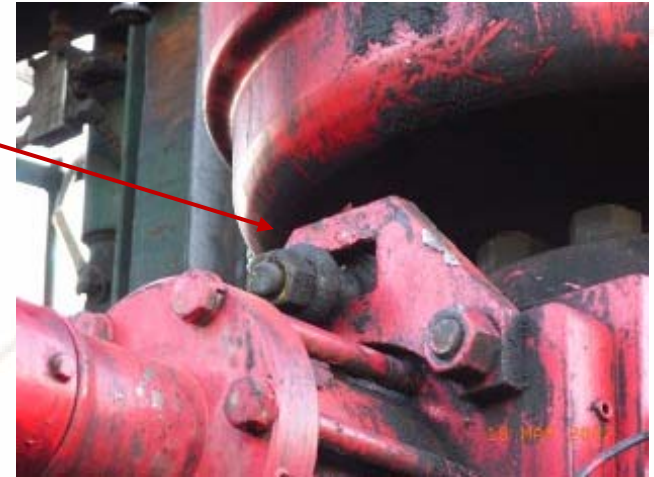
- Close-up of lifting lugs

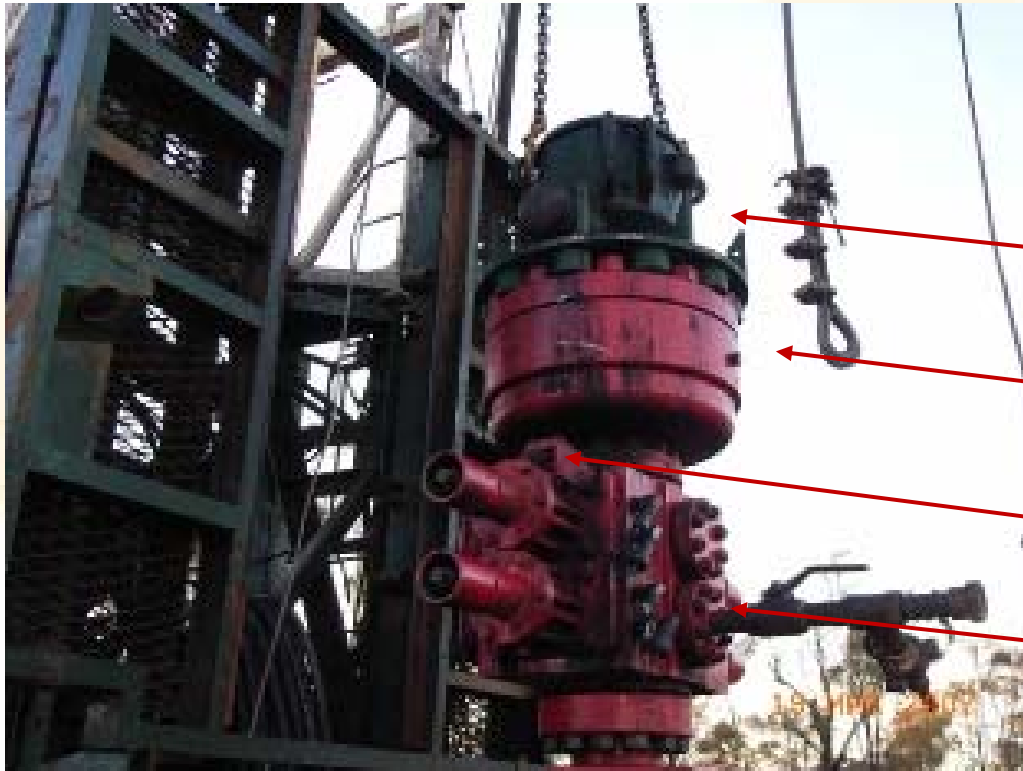
Rotating head

Annular BOP

Lifting Lugs

Double gate BOP

- The usual lifting pad eyes were used to pick up the top half BOP
- The BOP toppled over due to the weight of the rotating head causing the BOP to become top heavy
- Fortunately no-one was injured and no equipment damaged occurred

- Crew was debriefed on the incident at crew change (midnight)
- Crew was advised to stop work if any practice is unsafe and the requirement for JSA's when circumstances or plans change was reinforced
- Field safety advisor spent 2 days on rig providing JSA training
- SOP for rig up / rig down of cavitation stack revised and reviewed every time
- Lifting eyes on rotating head found to be certified for lifting the head only

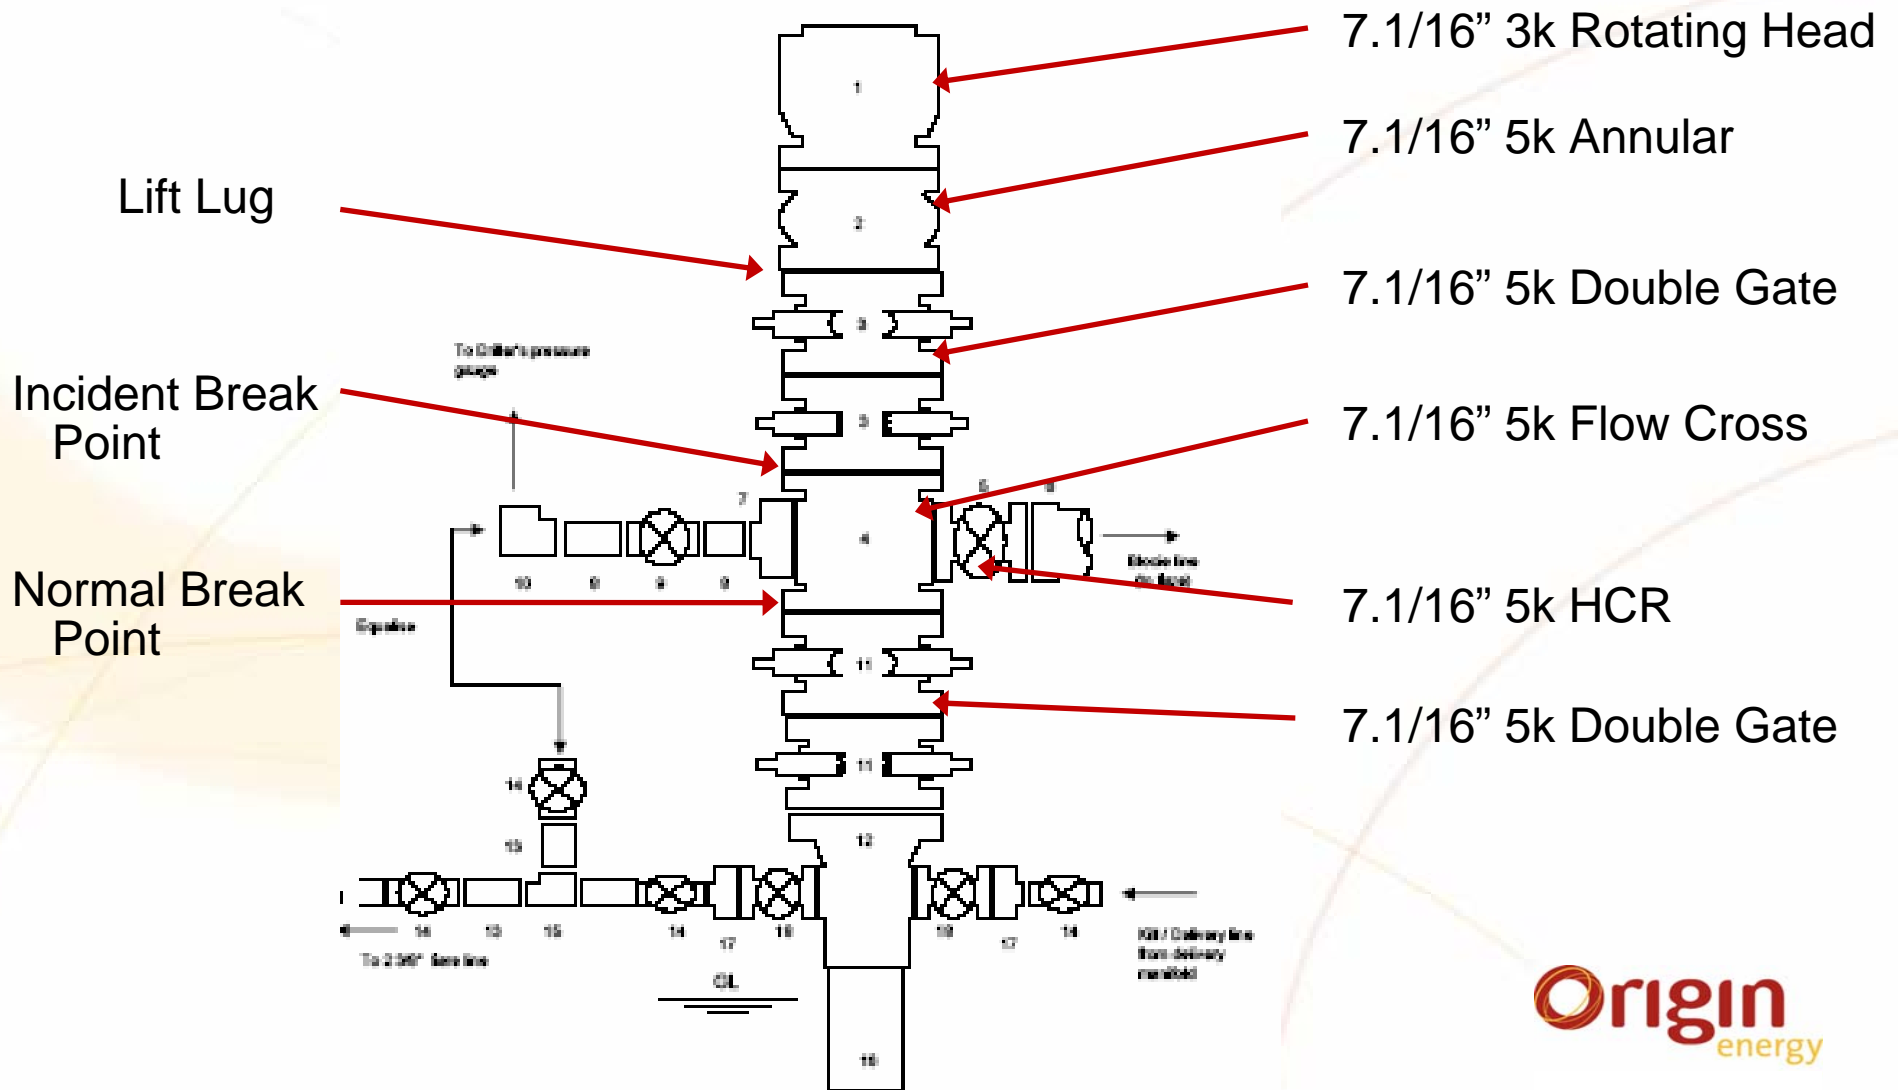
- A JSA was done the night before for the removal of the complete cavitation stack
- There was no SOP or JSA for the installation of the top half cavitation BOP
- No-one identified the issue of incorrect weight distribution on the usual lifting pad eyes
- The rotating head has lifting eyes on the top however there was no record of safe load limits
