# DRILLSAFE MEETING

## FALL FROM PERSONNEL BASKET

Actual Level 2 / Potential Level 4

Development Driller 1 – Gulf of Mexico

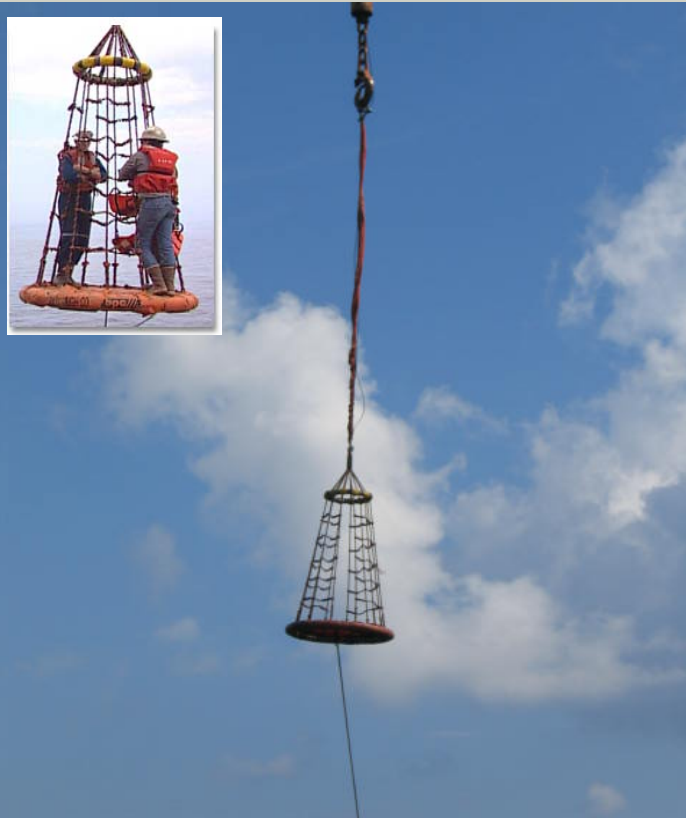
Type of Billy Pugh Involved

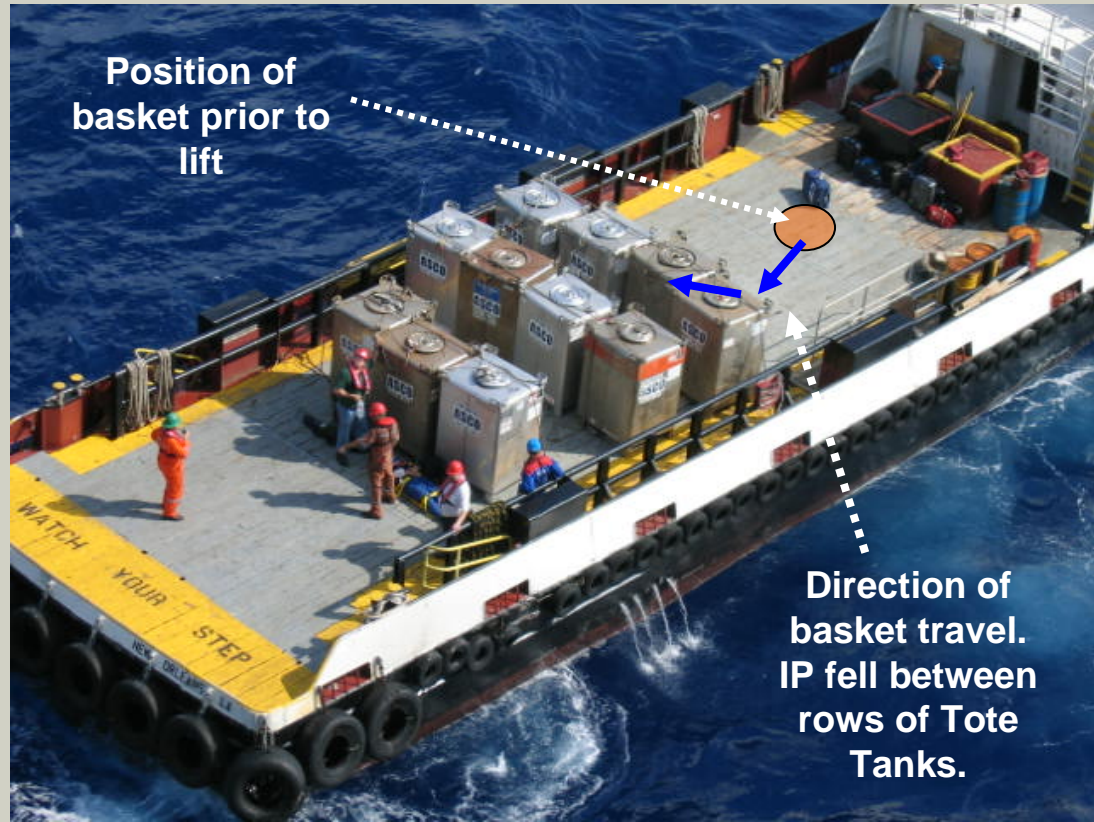
Incident layout

- The vessel rolled / dipped in the swell and the basket was lifted from the deck and swung towards the tote tanks. This was exasperated by the fact the crane boom tip was not directly above the basket

- The crane operator, in an effort to prevent the basket from striking the Tote tanks, came up on the basket
- The basket struck the outermost Tote tank and spun, striking the next inboard tank on the deck before clearing the tanks and stopping ~3m from the deck

- The IP was dislodged from the basket by the impact with the Tote tanks / movement of the personnel basket.
- The IP fell onto the top of the Tote tanks, rolled off and then fell between the two rows of Tote tanks, striking them with his head and back before landing on the deck
