Caught between results in LTI crush injury

26th June 2008

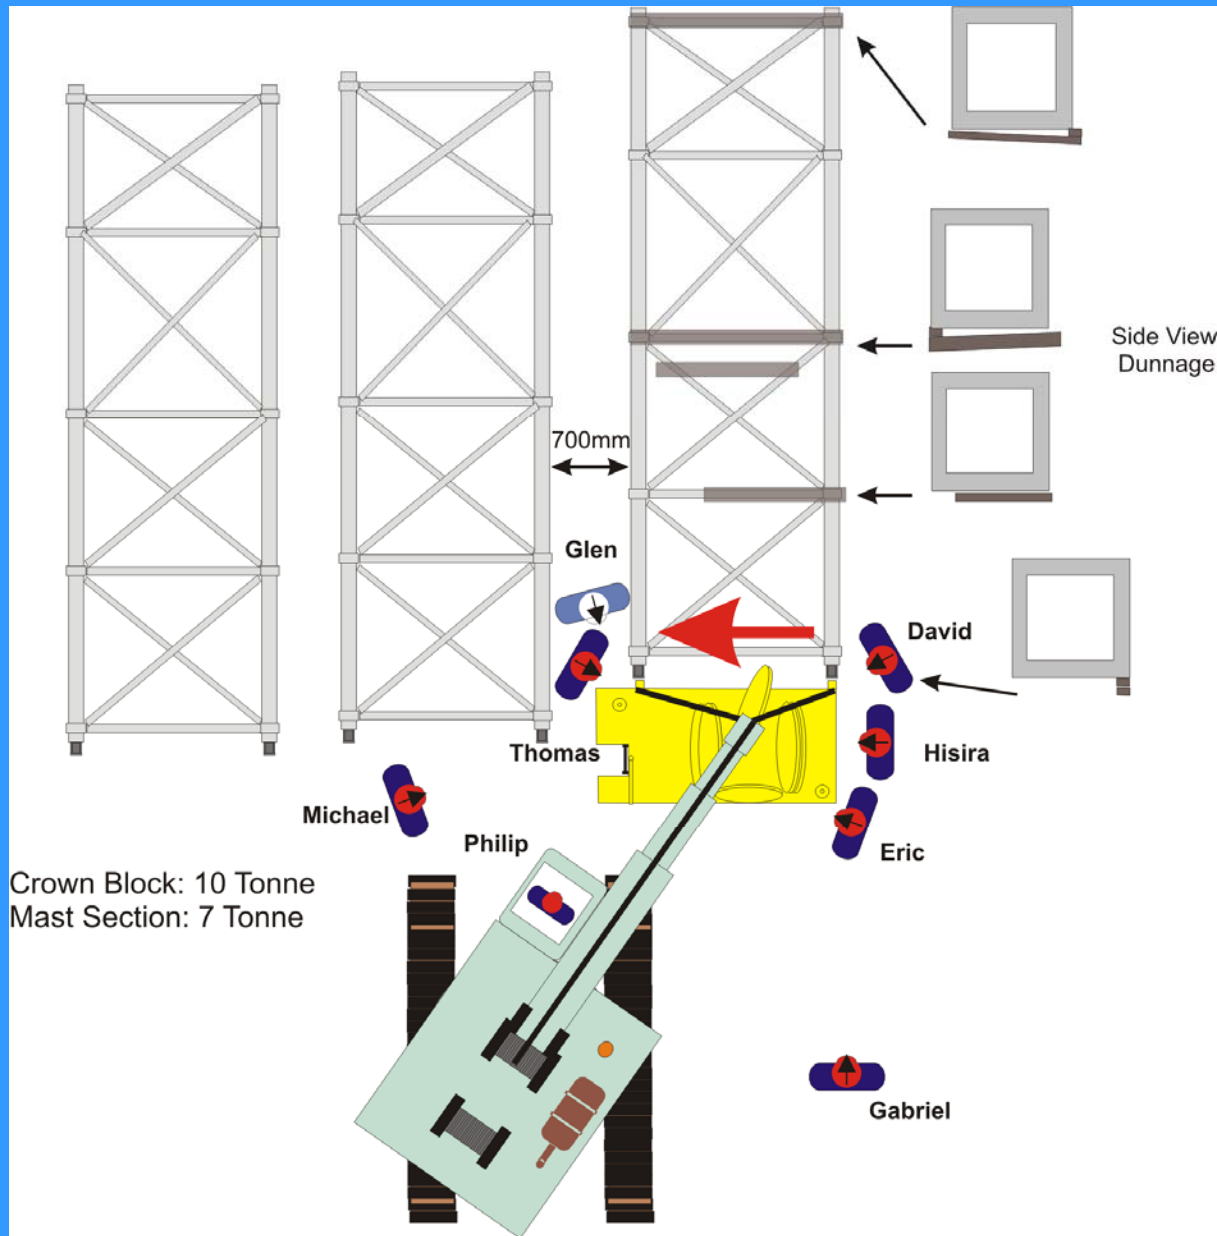
Event Description	Time Period (hours and seconds are approximate times)
Roustabouts stood by on either side with sledge hammers to drive pins in.	0930
On the first attempt the lugs and sockets did not line up. Backed off with crane by minimal movement.	
Second attempt made – better alignment. Driller signalled slow movement down	
Lugs were lowered into the sockets	
As the crown was lowered the weight of the mast was now being taken up by the mast.	
Mast and crown moved sideways toward Supervisor and IP	
Lug came out of their sockets and crane section continue to move towards IP	
INCIDENT – IP CAUGHT BETWEEN CROWN HANDRAIL AND OTHER SECTION ALONGSIDE THAT ONE BEING PINNED.	0950

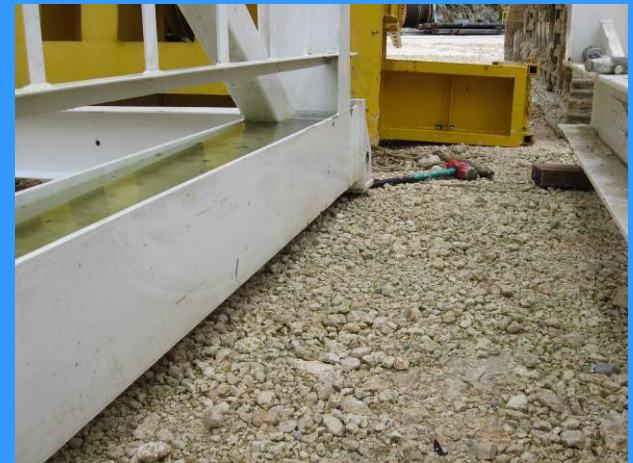
- Dunnage boards under the mast failed
 - Dunnage under the mast section were of poor size and inadequate.
 - Size and placement showed little thought when stacking
 - Inadequate dunnage not recognised in pre job
- Weight applied down on the mast
 - Dunnage were not consistent and no boards under the mast end where the incident happened. The load bearing down on the socket without dunnage moved the combined load sideways.

No.	Action	By whom	By when	Remarks
1	A set of purpose built stands to be fabricated for supporting the mast off the ground during the rig up activity and storage.	Field Supt	31Aug	Two prototypes complete. A total of 8 required.
2	Develop a procedure and dedicated JSA for assembling the mast sections	LF Toolpusher	31Jul	Two different procedures available with rig from China. Both conflict.
3	Drillers and above to received supervisory safety training in <ul style="list-style-type: none"> • JSA production and implementation • Use of procedures • Roles and responsibilities of supervisors • Job planning and leadership 	Training Manager	To be completed by 31Dec08	Initial meetings held with EDN. Plan is to start in September.
4	All HAES personnel to participate in training of lifting and rigging by a certified training establishment to Aust Standards.	Training Manager	To be completed by 31Dec08

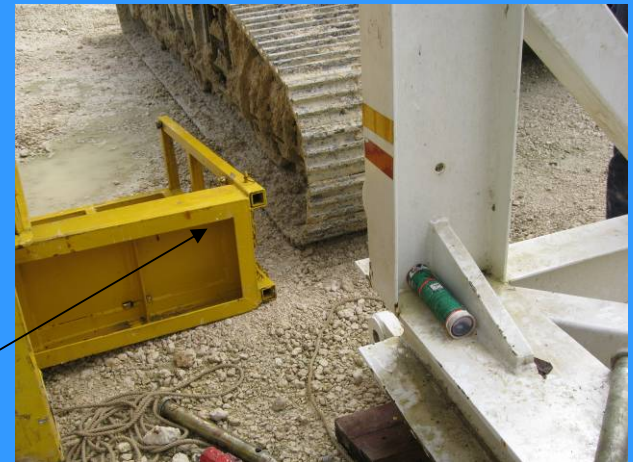
Handrail that trapped IP

- Restricted work space.
 - Supervisor and IP stood in the restricted area.
 - No escape route.
 - Other equipment too closed
 - Overall lease space limited because of Civil works ongoing work
- Insufficient Planning
 - Pre job did not address the hazards. Focus on the job at hand
 - No JSA in place
 - Pre job was verbal and not recorded

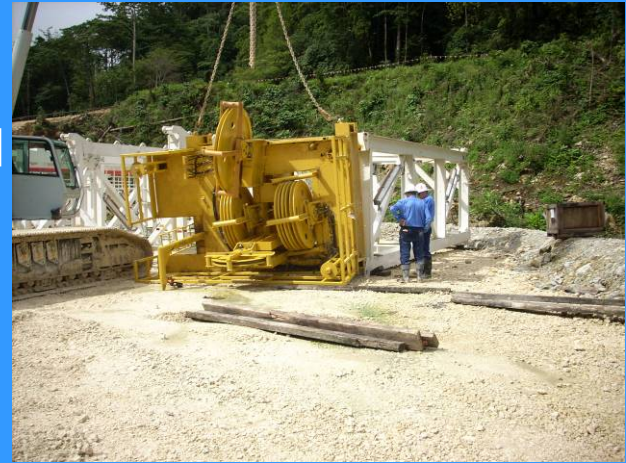
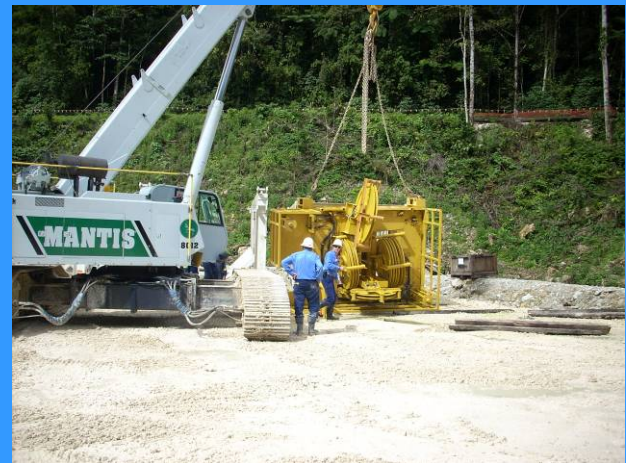
- Lack of supervision
 - Supervisor stood in the restricted area.
 - Supervisor acted as dogman which took him away from supervising overall task.
 - Supervisor did not ask others for comments i.e. hazards.
