Atwood Eagle

Crushed Finger – 14th October 2006

Crushed Finger Incident Summary

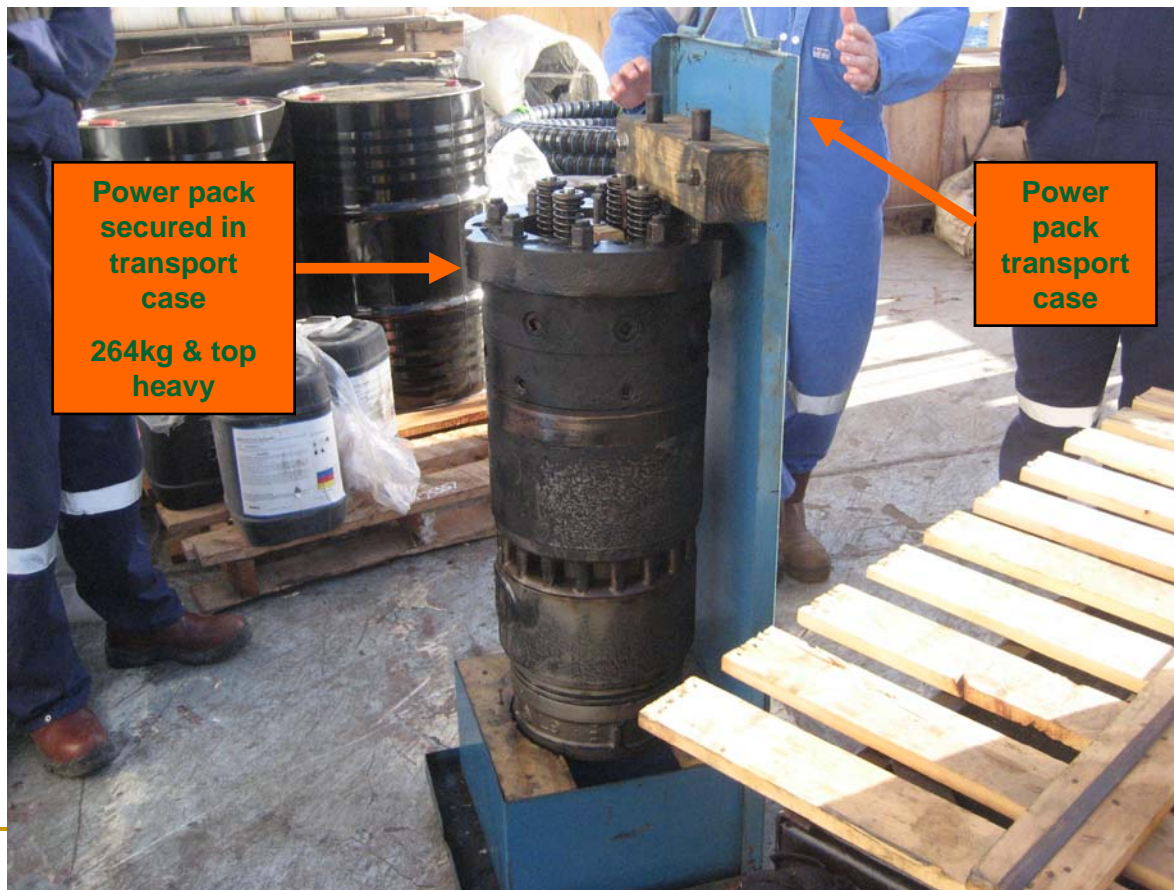
Activity at Time of Incident – Transfer of a power pack from outside of the engine room to the offloading storage area Starboard deck using a two wheeled trolley.

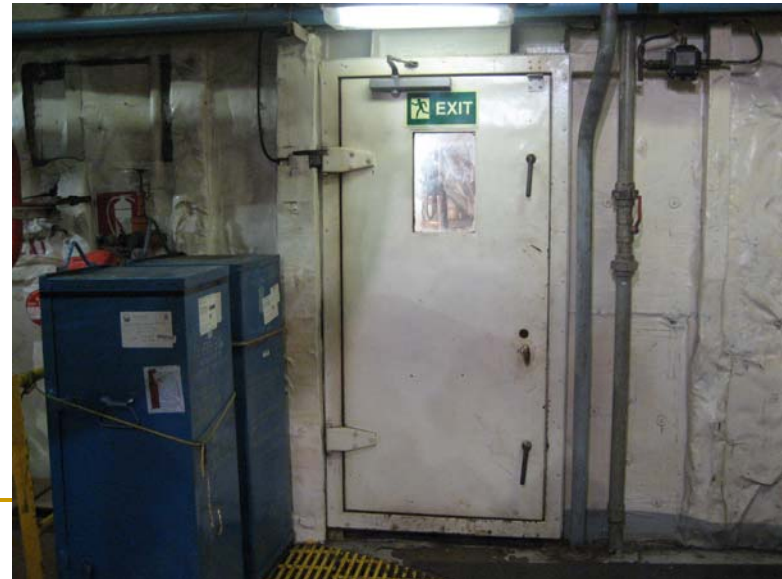
- Toolbox meeting held to discuss movement of power pack through a water tight door and to the storage point. The weight of the unit was discussed, but the transfer method was not
- Motorman & two roustabouts successfully move power pack out of engine room through watertight door manually using a two wheeled trolley

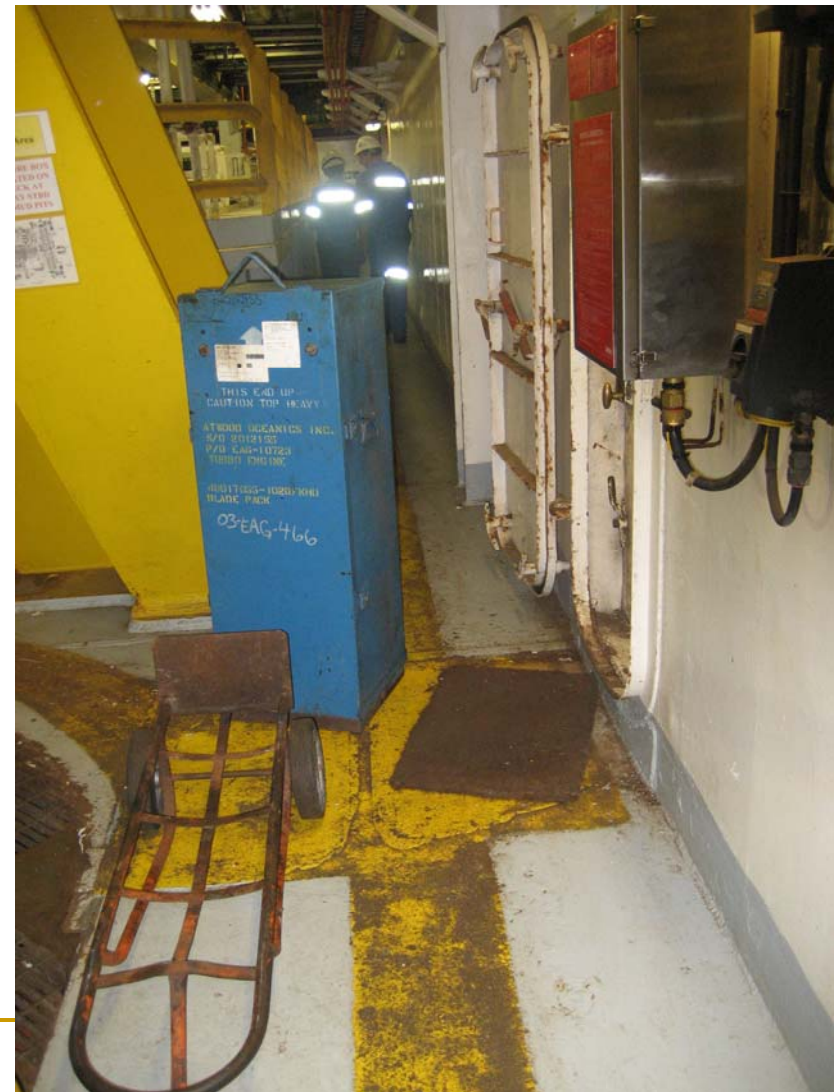
Top View of Incident

- With the power pack and trolley now outside the engine room, a roustabout (IP) promptly took hold of the trolley and lifted the power pack back on the trolley
 - At this point the IP was unable to control the load and it continued coming down past the point of equilibrium
 - The IP attempted to catch the load and prevent it from falling and in doing so caught his right hand little finger between the trolley handle and deck resulting in a compound fracture
-

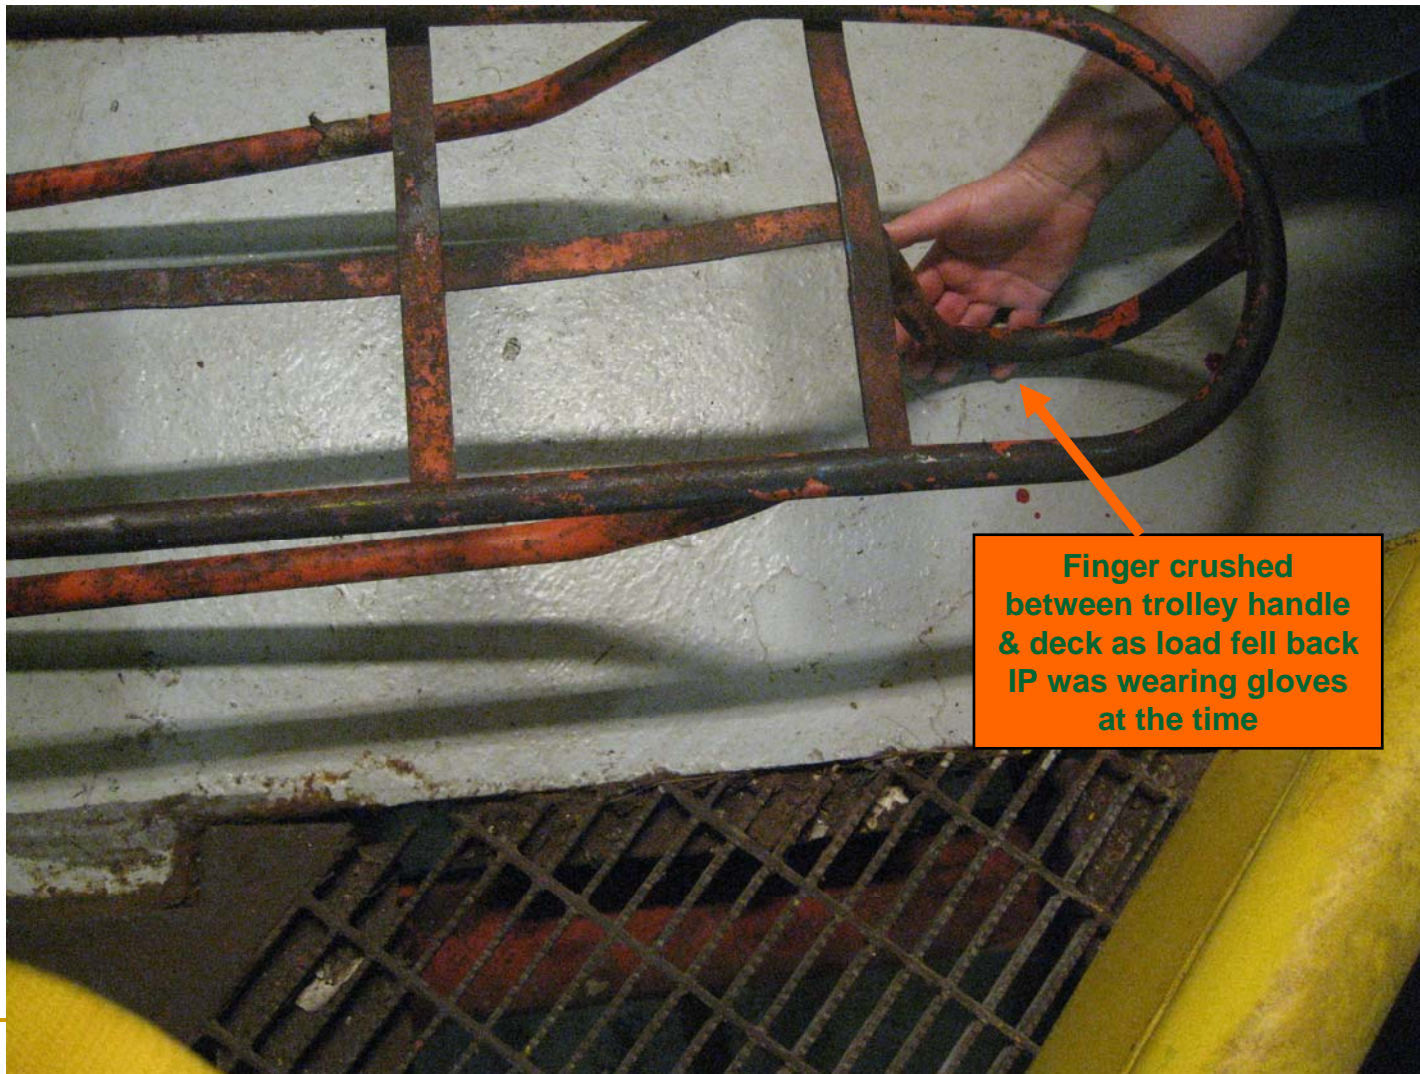
Finger crushed
between trolley handle
& deck as load fell back
IP was wearing gloves
at the time

- Install mechanical lifting / trolley securing arrangement for this task
- Conduct hazard hunt across rig to identify areas where mechanical lifting points are required
- Develop a JSA for handling power packs and other similar activities as identified from the hazard hunt
- Educate crew on the suitability of various trolleys and hand safety

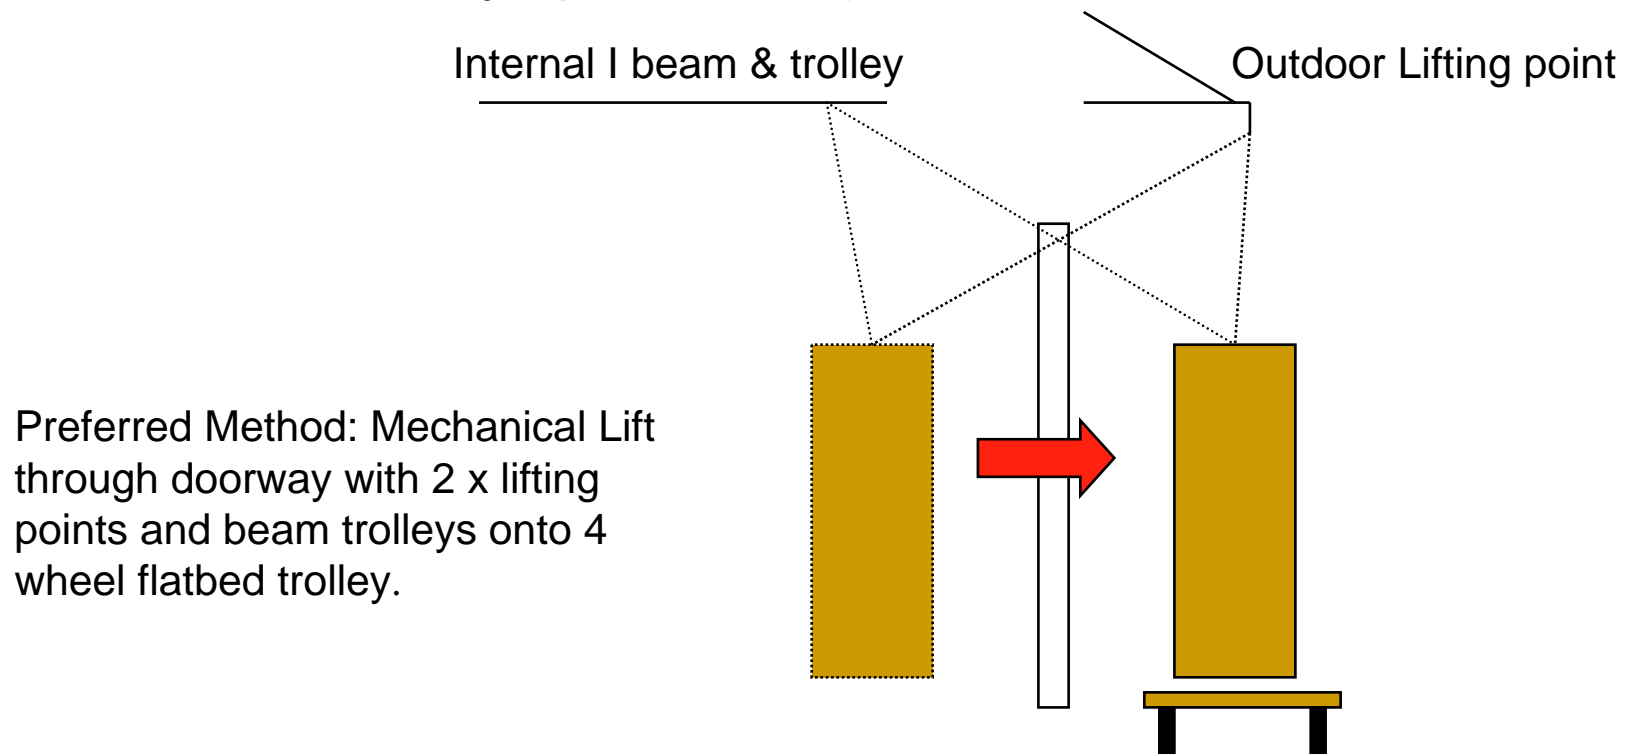
- Lack of mechanical lifting points made use of ideal trolley (4 wheel) difficult
