GEODYNAMICS
LIMITED

Dropped IBOP Actuator Arm

Dropped IBOP Actuator Arm - Chronology

RIG 100 Work floor

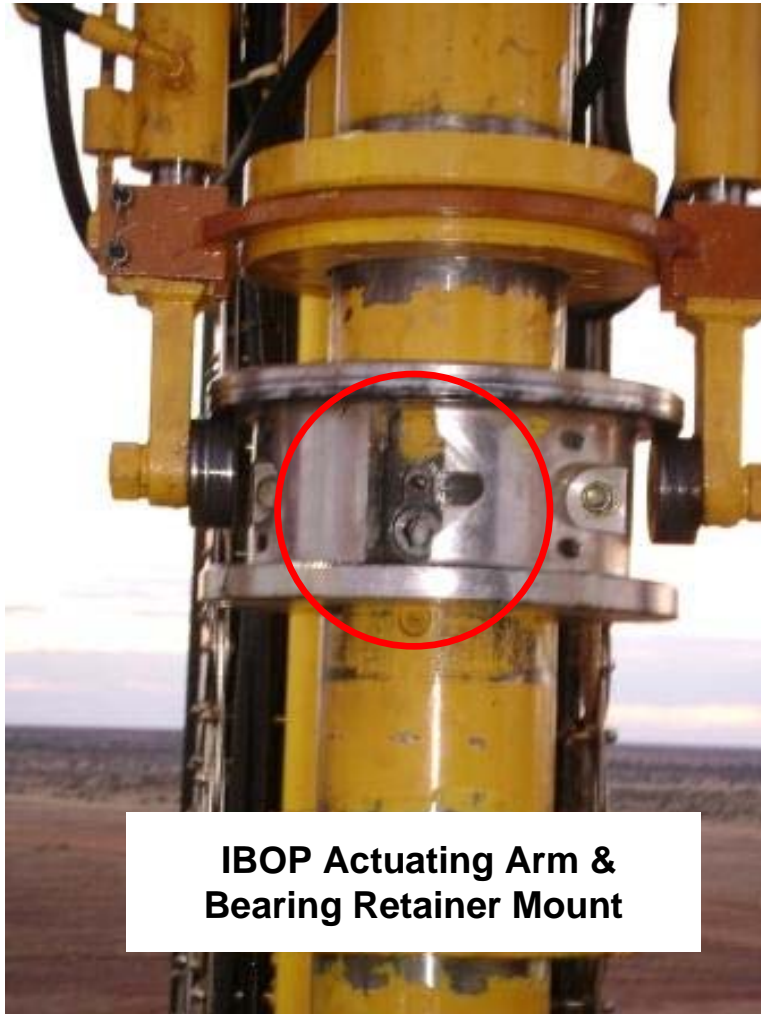
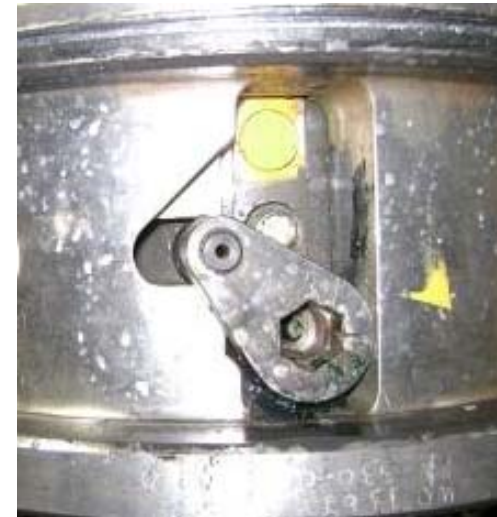
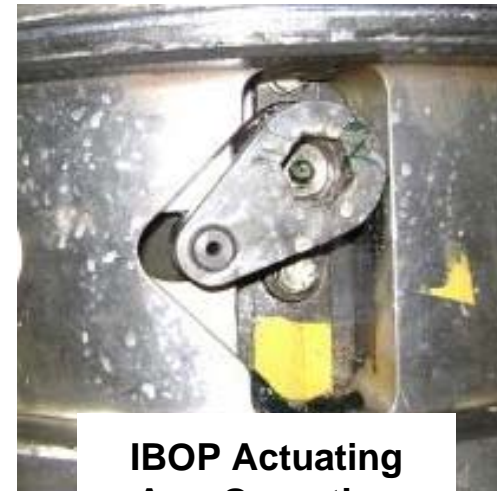
- Made up the first stand of heavyweight (first connection to be made from the monkey board).
 - Drilling resumed, within two minutes the IBOP actuating arm fell approx 90' out of IBOP bearing retainer mount to the rig floor.

1. Loose bolts on IBOP actuator arm bearing retainers.

- The assembly is fitted through the actuator sleeve preventing a clear view of the mating surfaces and protruding circlip.
- There was no locking system in place to prevent the retainer bolts from unscrewing.

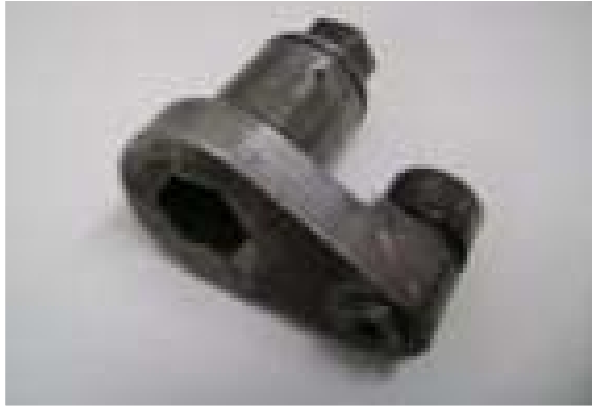
IBOP Actuating arm (dropped object)

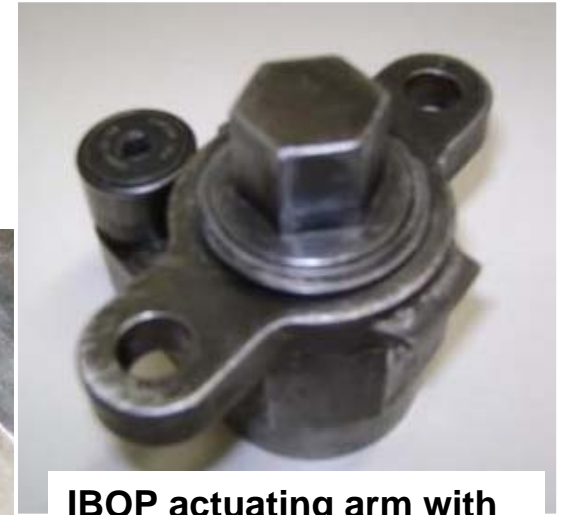
IBOP actuating arm with retainer

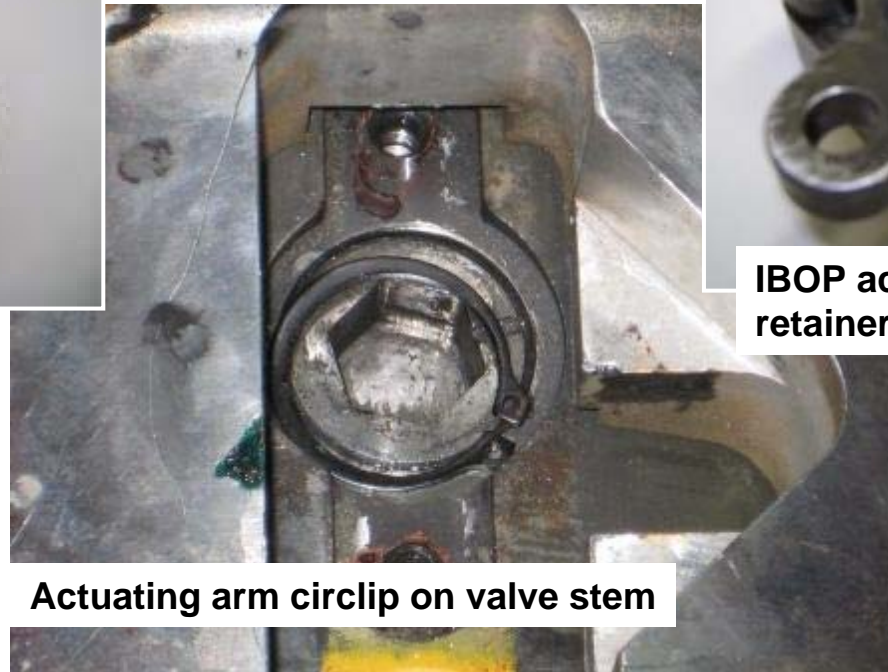
Actuating arm circlip on valve stem

3. Inadequate clearance for actuating arm circlip inside IBOP housing

- Equipment design needs improvement - a simple dimensional check on the design documents by another party should have identified the problem .

- Design, manufacture and install a retainer plate as secondary fall protection for the actuator arm.
 - Use a MOC process to review the new design ensure the new design of the product does not compromise any other function and to ensure all implications are understood and addressed.

- Issue a product alert to inform end users of the valve stem manufacturing defect and recall for modifications all units in service.
 - Review and modify engineering change procedure to ensure the final product assembles and operates as designed and intended (Issue previously identified).
