GEODYNAMICS  
LIMITED

# Dropped Sheave Saddle Bracket

# Dropped Sheave Bracket - Chronology

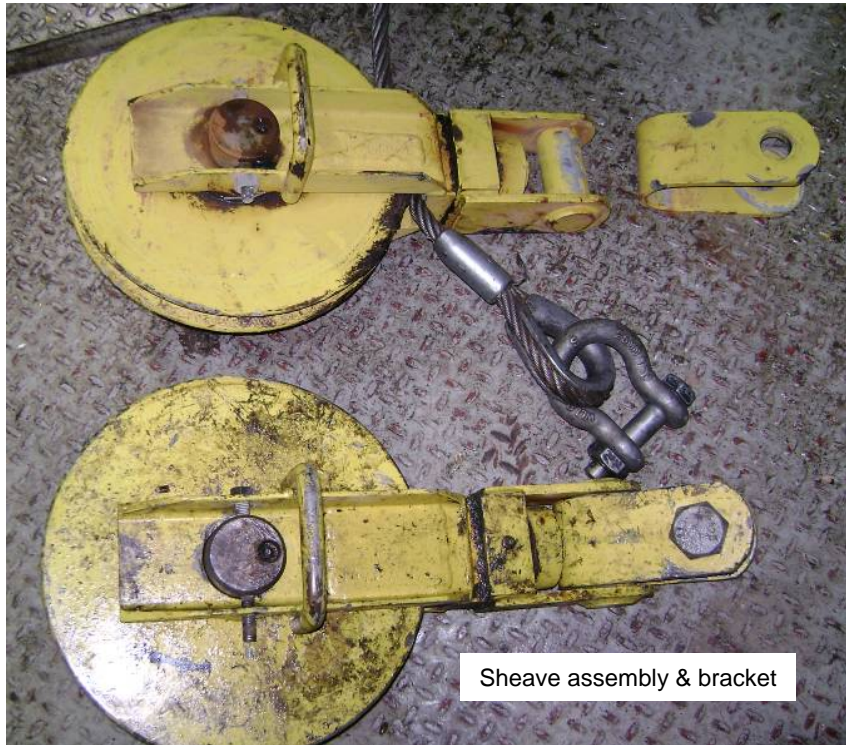
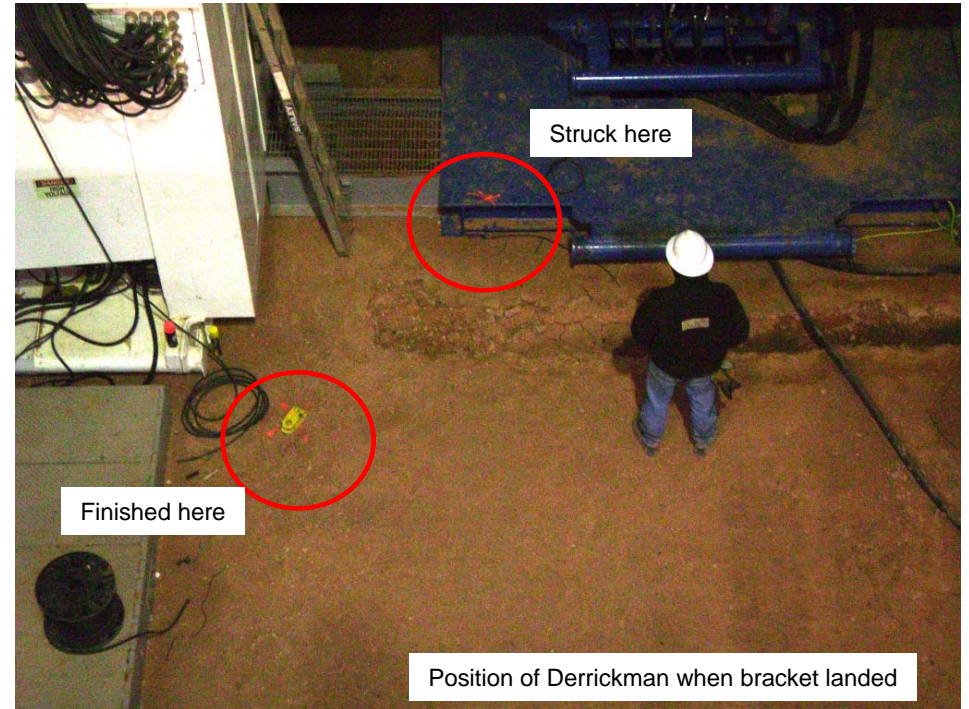
# Dropped Sheave Bracket

- Attempt to free the jammed winch line without success.
- Need to detach sheave - a harness was placed around the sheave to secure it when detached.
- A locking pin and nut was removed from the bolt that secured the sheave bracket to the pad eye. When the bolt was removed the bracket twisted around and fell free from the sheave block.

1. Lack of knowledge / experience/ training on rig specific new design equipment. No SOP for stabbing board operation available.
2. No counter weight on the end of the winch line.
3. Winch line sheave position in relation to the task resulted in an over head work position.
4. Driller was fatigued after ascending and descending the mast twice, as well as pulling through the winch line. Incident happened at end of shift at midnight.
5. Design of equipment (2 piece sheave block): Failure to identify risk of the sheave design fault during rig assembly & commissioning process.

- Obtain and install one piece sheave blocks in place of the two piece design.
- Update JHA training gaps within Rig 100 crews.
- Increase of key GDY/EWG personnel in future new plant acceptance - familiarise themselves with equipment, its installation, operation and removal; and to assist in creating SOP's for new equipment.
