**Rig Move LTI**  
**MDC Rig #151 – Raslie 9**  
**09:45 21<sup>st</sup> November 2007**

6 December 2007

# Incident Summary

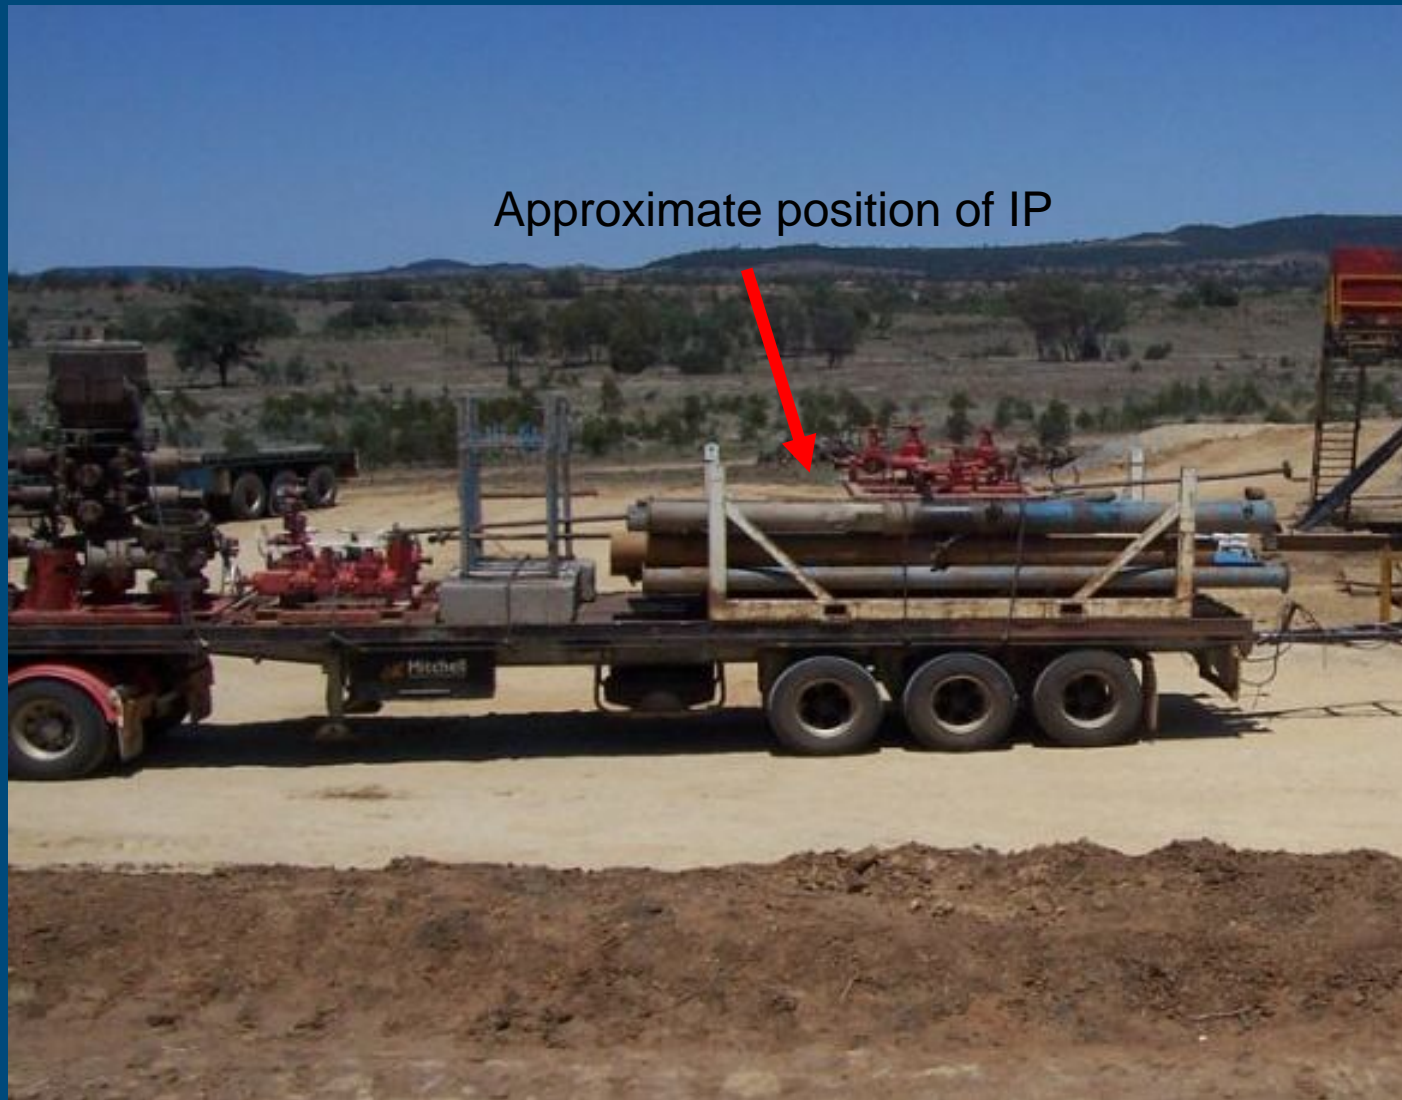
# Incident Photos

- IP climbed onto the trailer and onto of the flow line located in the bolsters to better position the dunnage (approx. 2.7m above ground level).
- The Derrickman noticed this unsafe act, and asked the IP to get down

- As the IP attempted to get down, the flow line moved causing him to fall to the ground injuring his elbow
- IP was taken to Roma hospital for X-rays and later transported to Toowoomba for surgery

- Implement detailed rig move plan for all future rig moves
- Crews to be reinducted on working at heights requirements
- Mitchell Drilling to outline crew expectations and standards, and enforce these were applicable
- Expectation of Site Supervisors to be reinforced
  - Requirement to stop operations in the event of non compliance with safe work instruction
- Currently rolling out a Safety Leadership Coaching program (to augment previous Safety Leadership courses)
  - Improve pre-job meetings/communication
  - Improve intervention skills

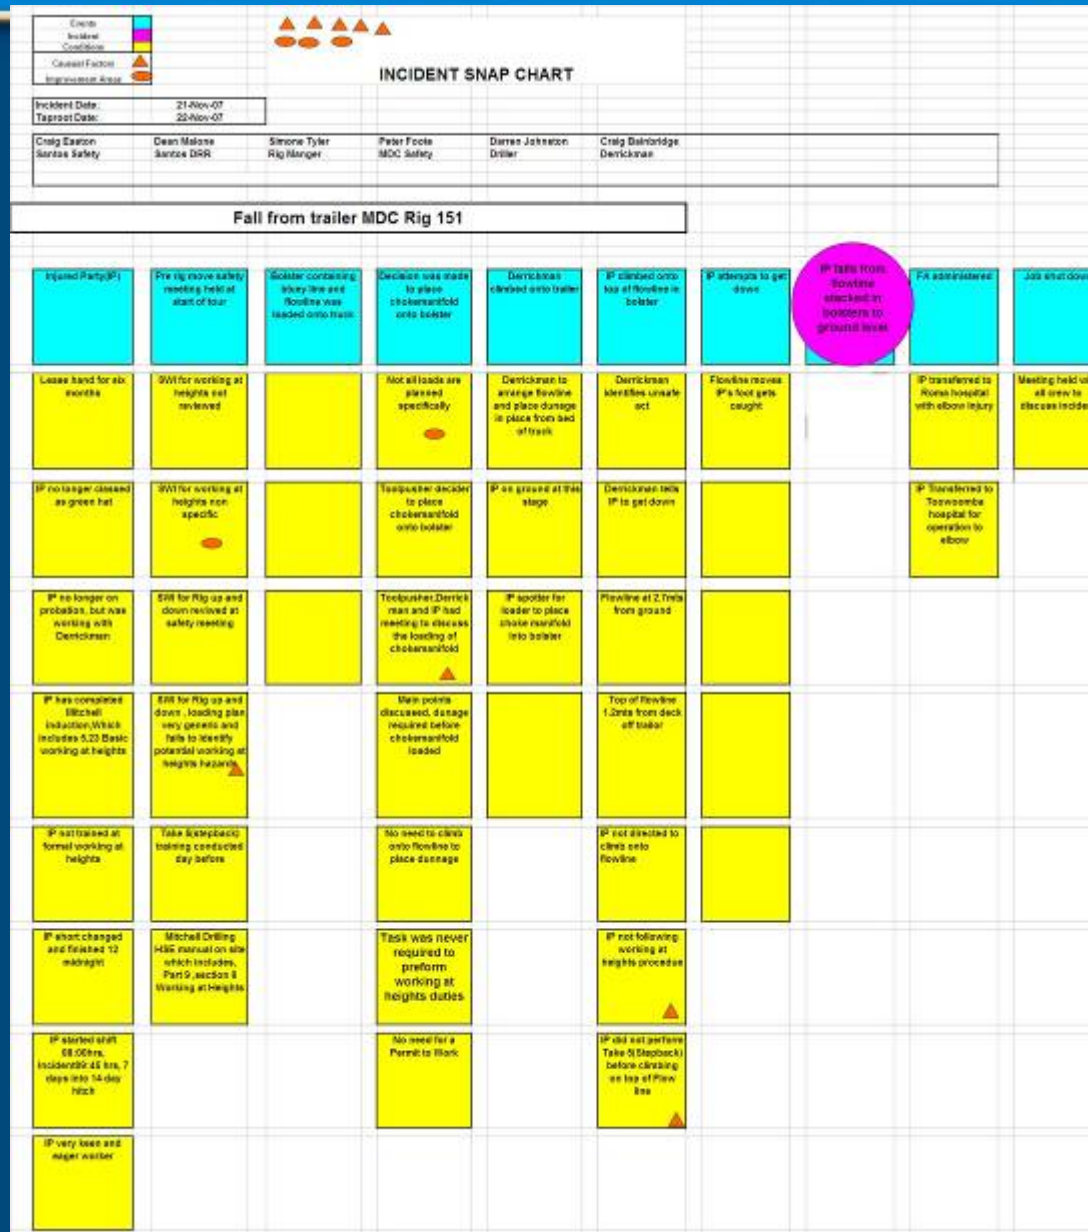
# TapRoot Snapchart

- **Causal Factor:** Not all loads are planned specifically (i.e. load plans)

Root Cause - Management System – Standards, Policies or Administrative Controls  
Need Improvement

- **Causal Factor:** TP, DM and IP had a meeting to discuss the loading of the manifold, additional hazards and controls were not discussed

Root Cause - Work Direction – Preparation –pre-job briefing needs improvement

- **Causal Factor:** IP not following working at heights procedures

Root Cause - Procedures – Not Used/Not Followed

- **Causal Factor:** IP climbed on top of load without instruction

Root Cause - Management Systems – Enforcement needs improvement
