DROPPED OBJECT SEDCO 703

Date: 15th September 2007
Client: Chevron Texaco

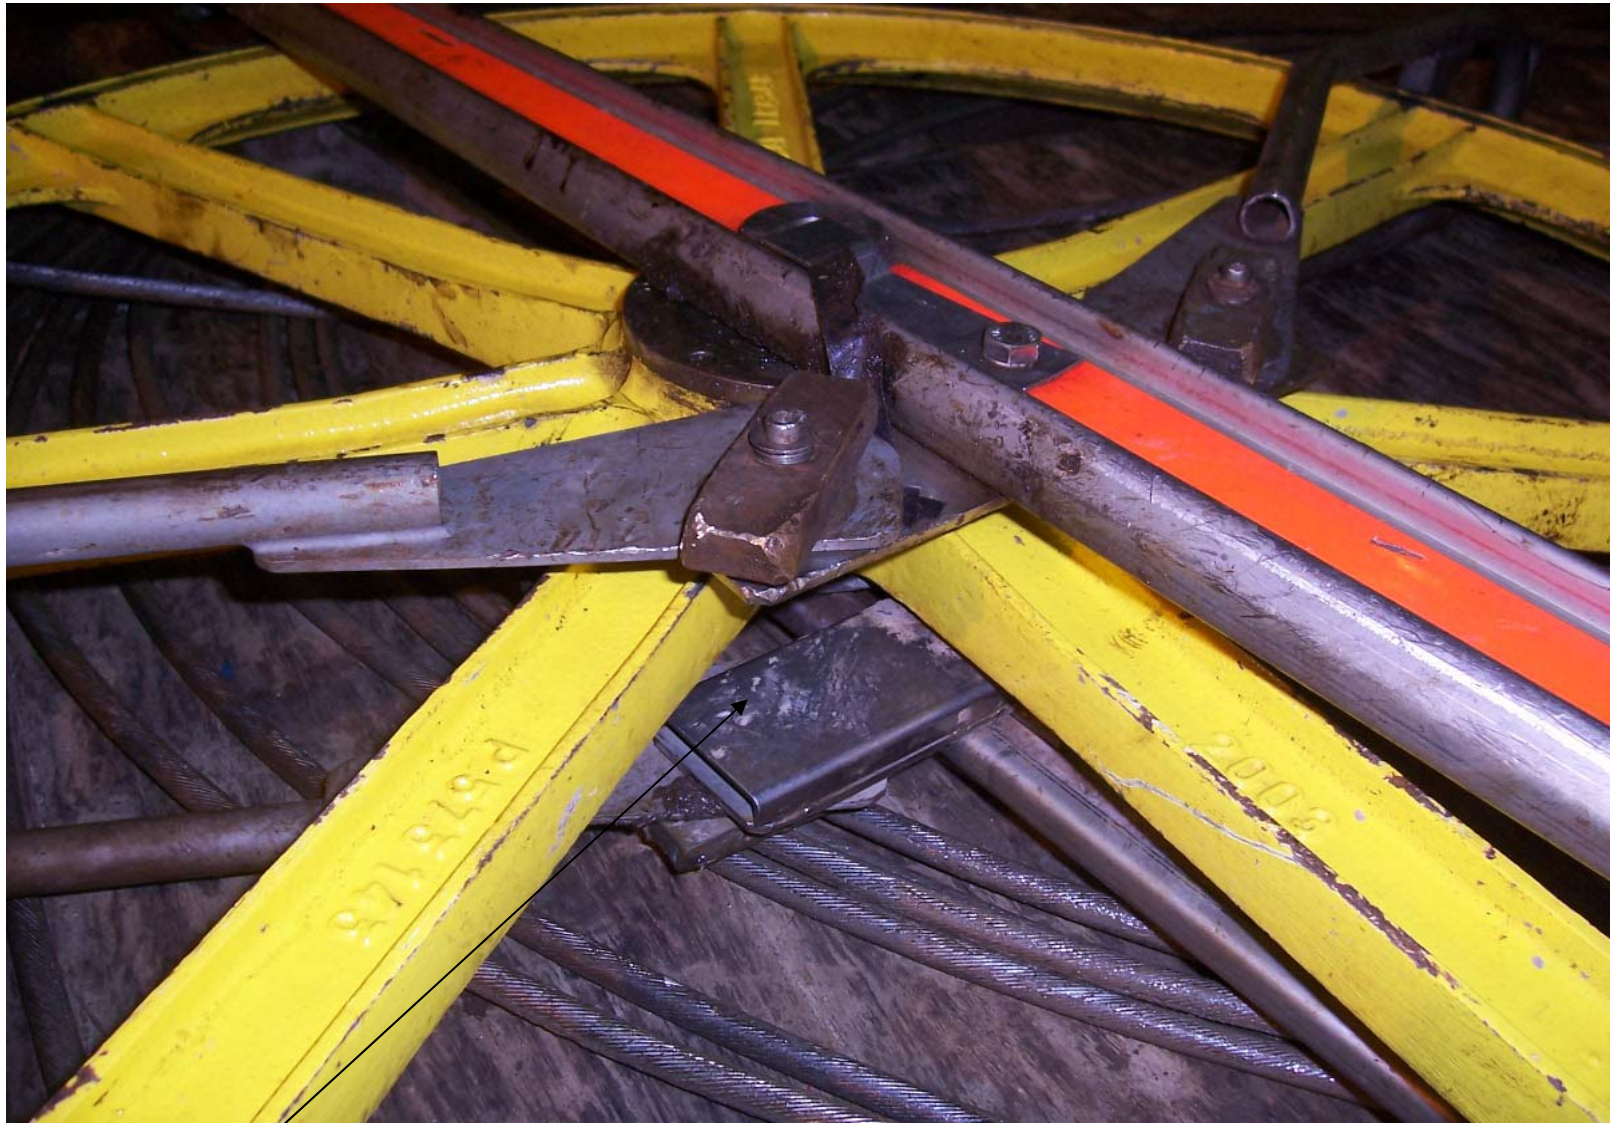
The potential for a dropped object was noted during the crew THINK plan hence no personnel were working below and the rig floor and cat walk areas were cleared, the channel piece on descent struck the V Door ramp (missing the drill floor) and landed on catwalk

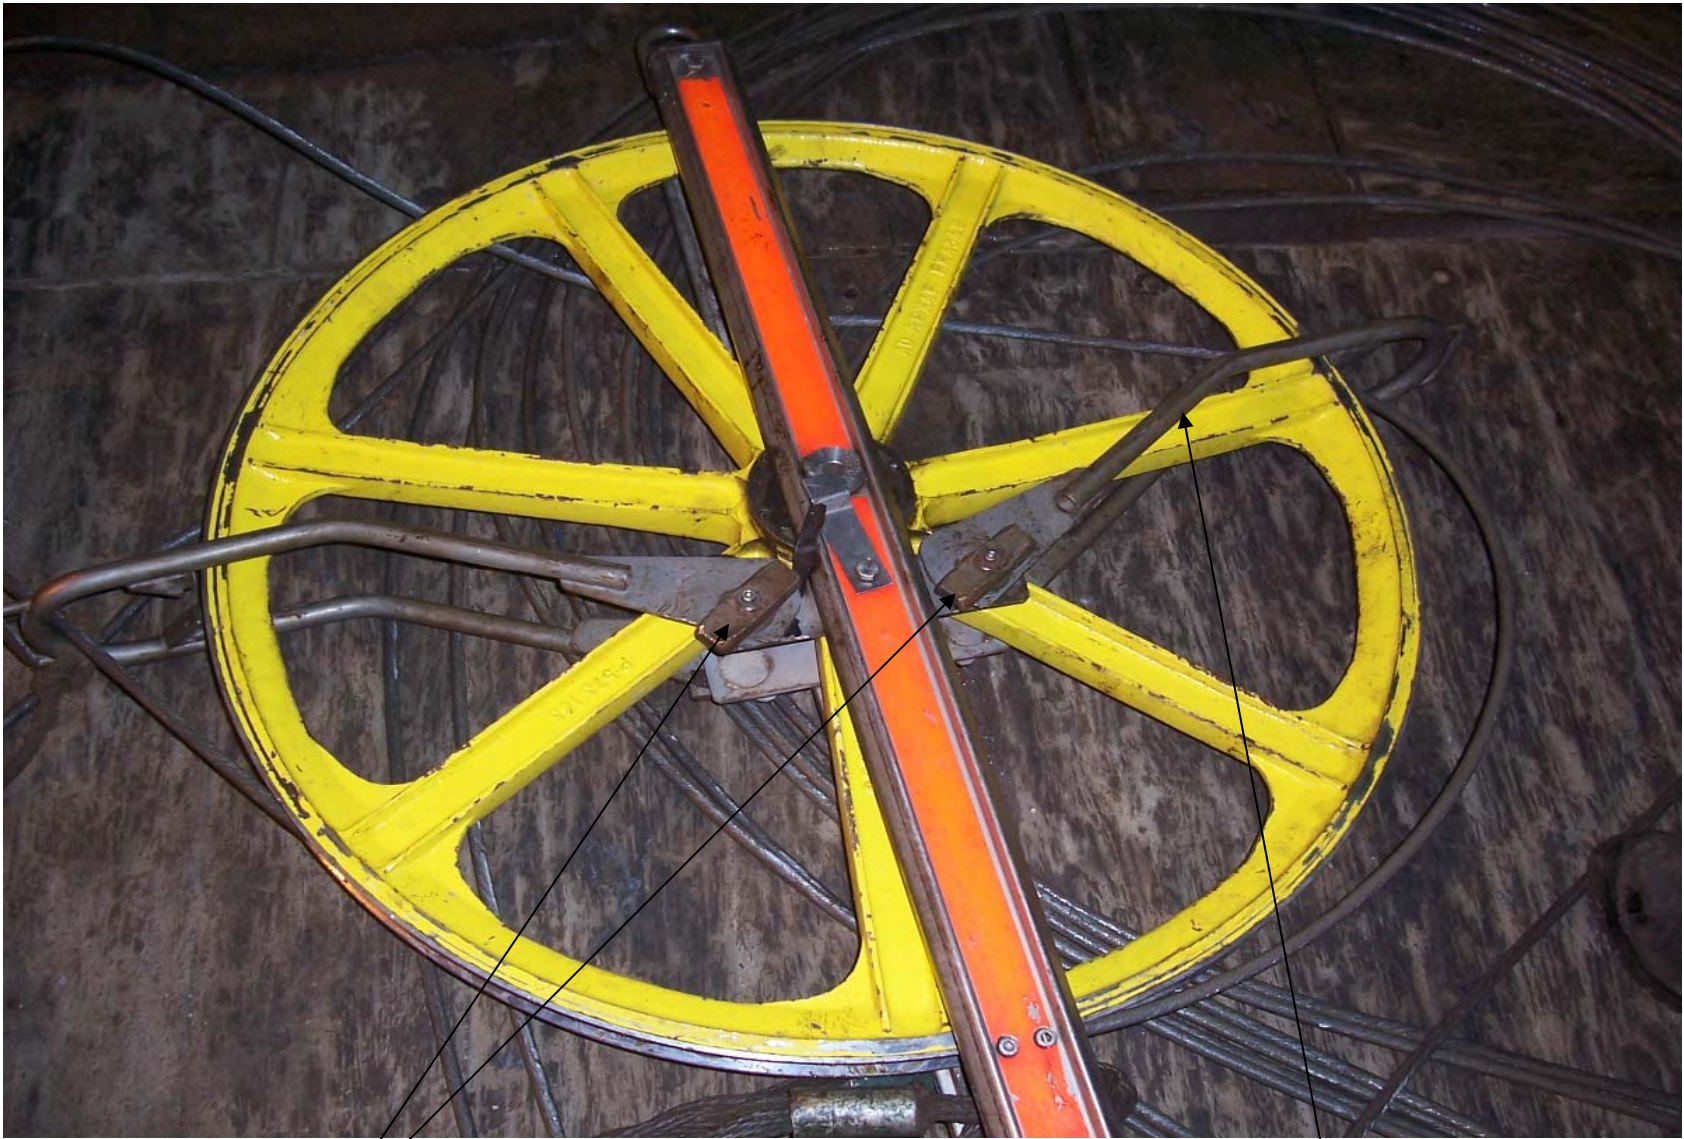
Stainless Channel

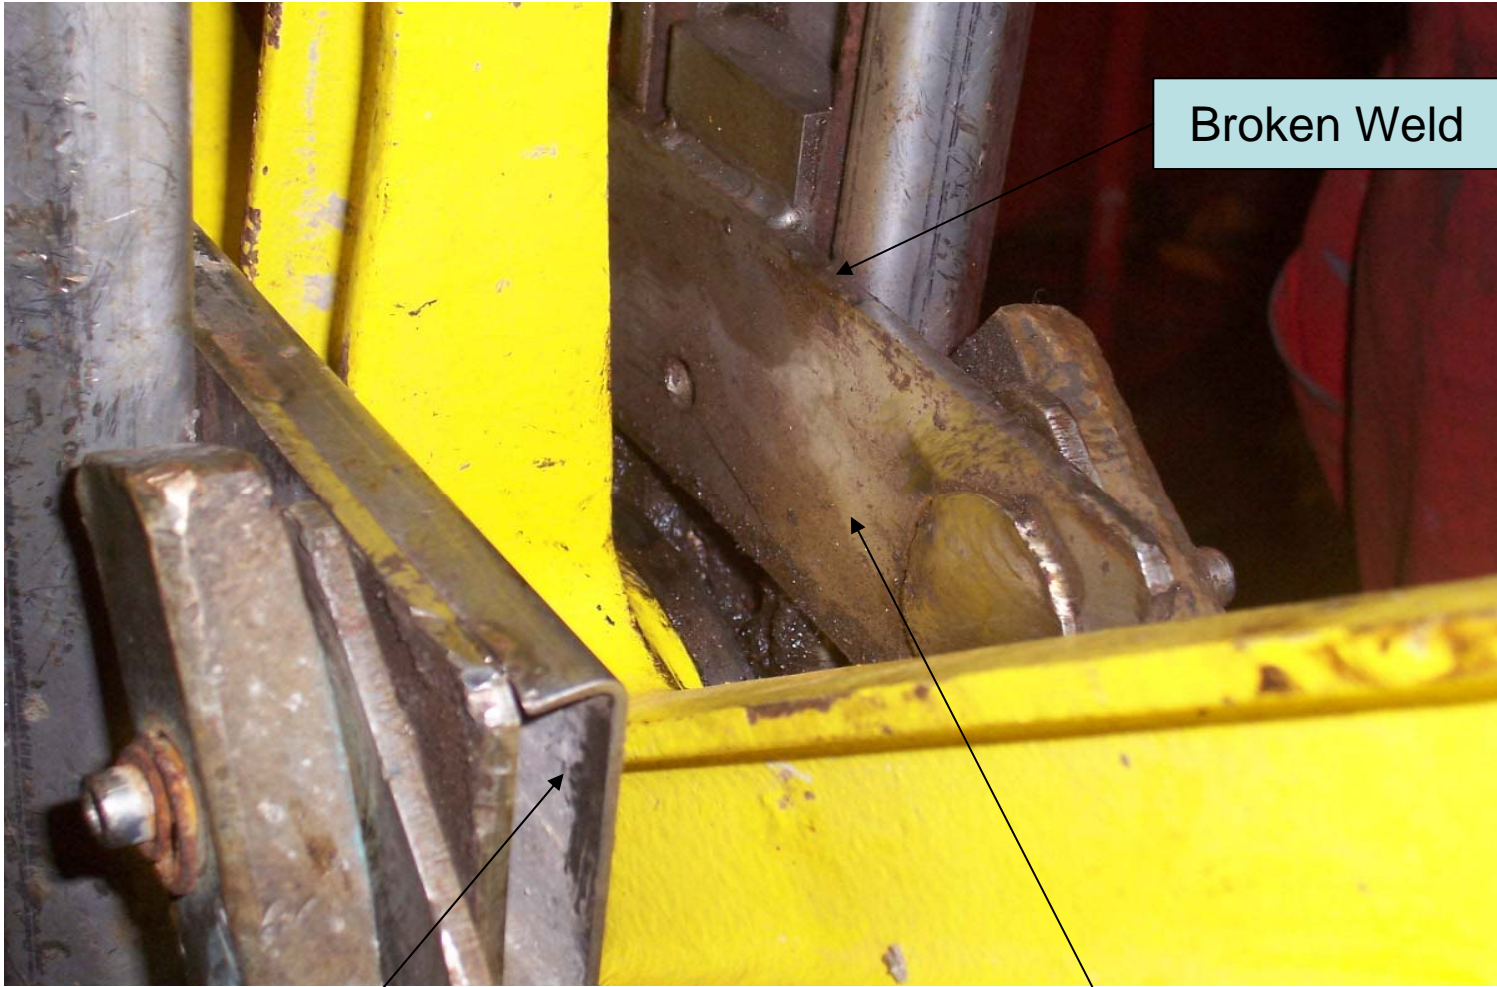
Adjustment for line retainer bars

Wire line retainer bars

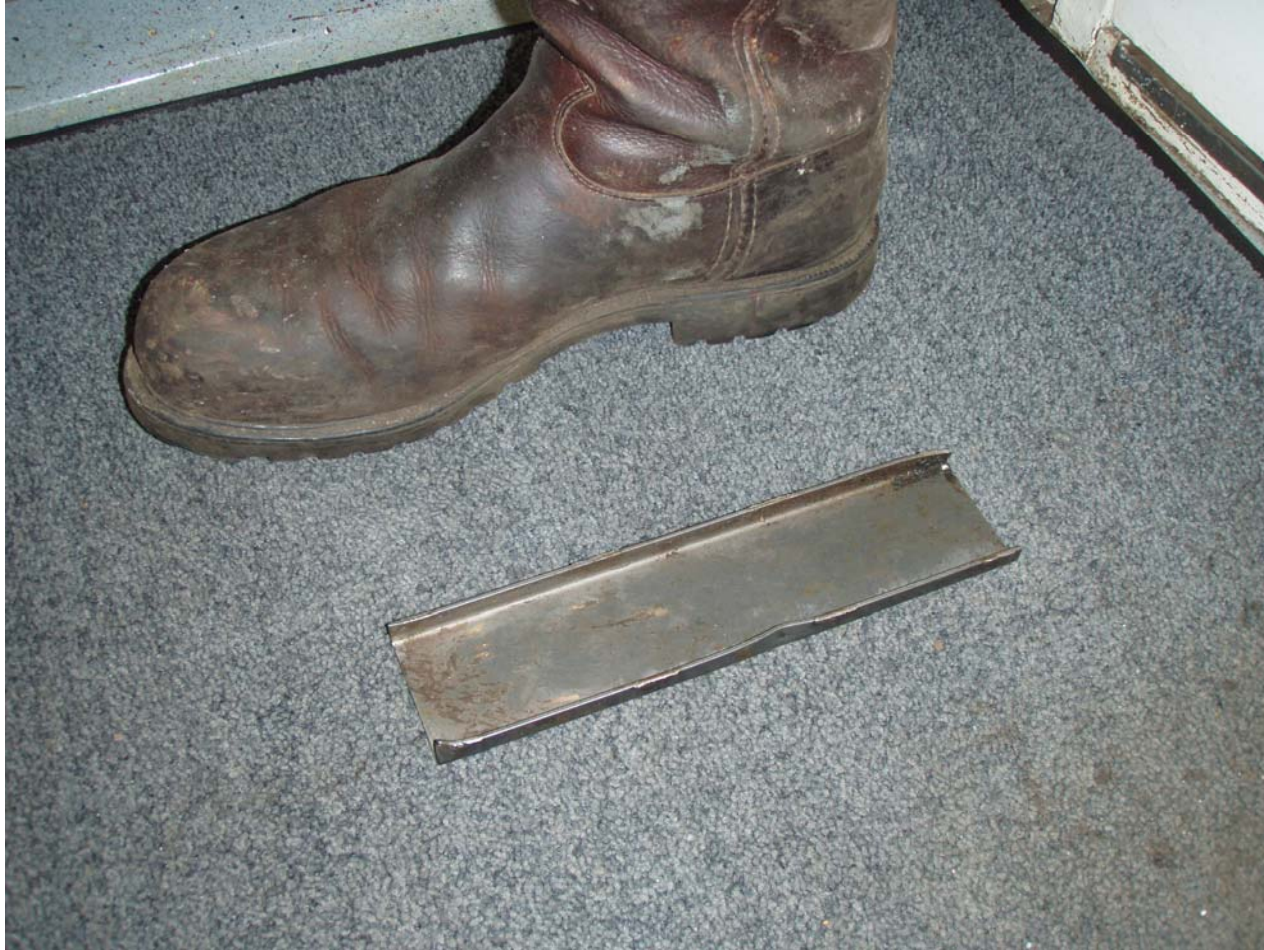
Broken Weld

Channel section in place

Missing Channel

Channel

- **Poor engineering design and Safety standard i.e. fracture of 8 tack welds along stainless steel plate**
- **No secondary fall restraint on the Wire line retainer mechanism.**

- **Australia wide Alert was initiated by Schlumberger (worldwide); reinforcement of channel**
- **Schlumberger looking into sheave modification**
- **Stainless Steel channel protects the headed bolt from debris and locking headed bolt when tightening wing nut.**

- **channel appears to serve no real purpose and should be removed.**
- **New sheave (different design) was sent offshore on next supply vessel**
- **After Action Review : TSTP modified to reflect the checking of sheave components and accessories prior to being hoisted into the derrick**
