LOADING CROWN SHEAVES INTO FLY BASKET RESULTS IN LOST TIME INCIDENT

Drillsafe
Brisbane

7th June 2012

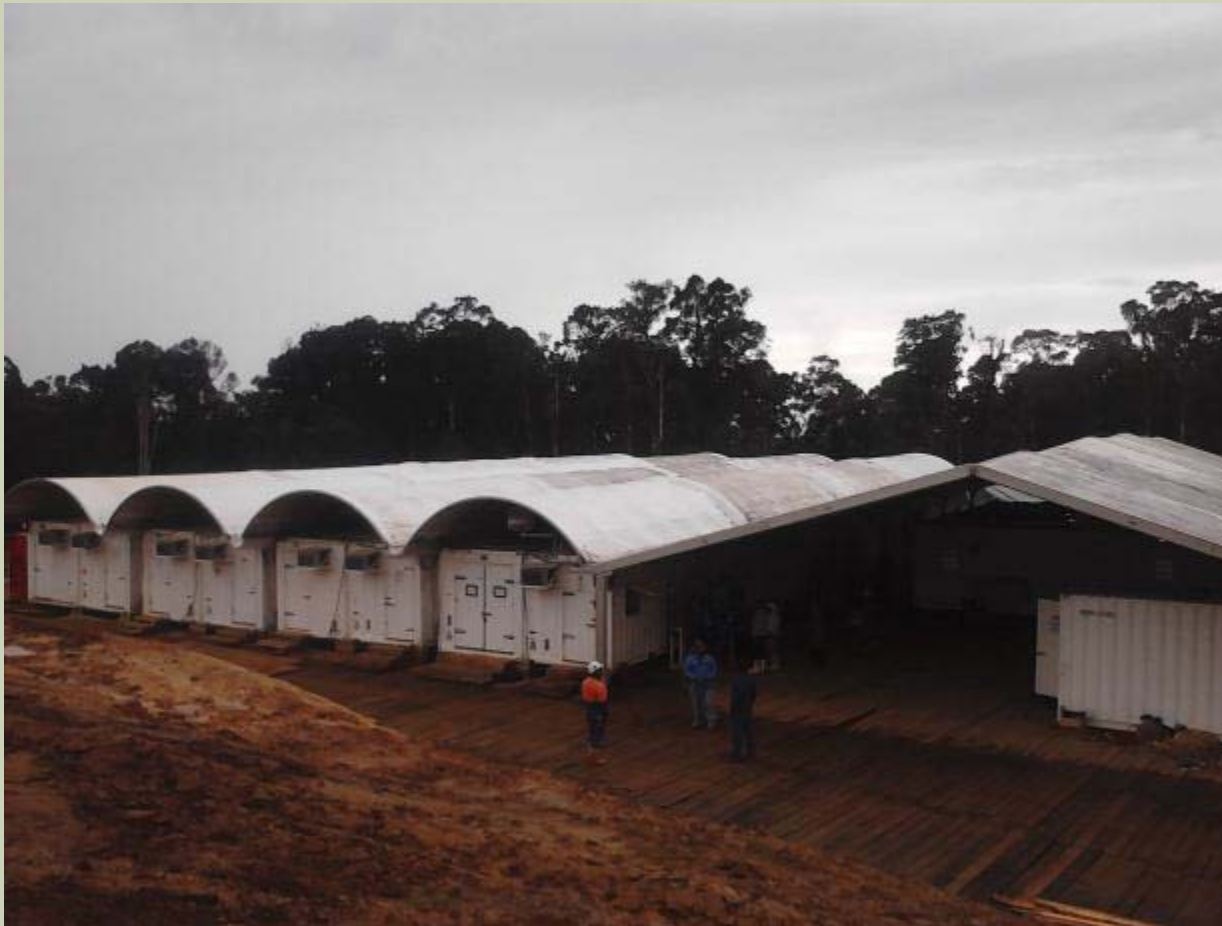
SEQUENCE OF EVENTS

The main task for the day was to erect the camp roof. The camp was separated from the rig site by a short distance.

Erecting the roof was expected to take the whole day and involved all Leap Frog (LF) crew members except the Senior Mechanic and Crane Operator who were at the rig site conducting maintenance.

When the LF Driller got to the rig site he started loading the four crown sheaves on to a fly skid assisted by the Senior Mechanic and crane operator.

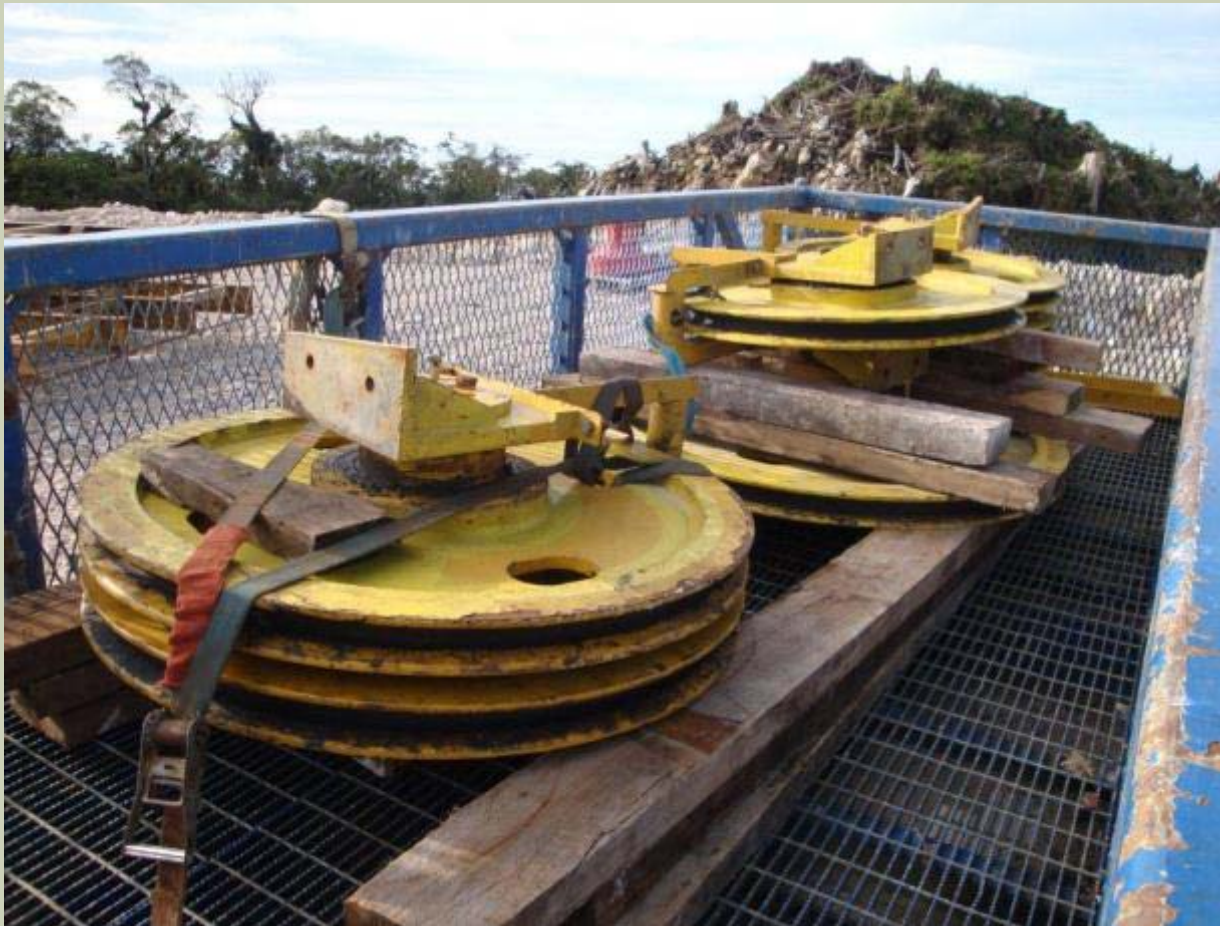
DY (wooden planks) were placed in the fly basket to rest the sheaves on. The DY was stacked 3 high along both sides of the basket running from front of the basket to the back.

The first two sheaves were loaded into the fly basket using two soft slings hooked to the crane. The slings were run through two eyelets on either side of the sheave.

The first sheave was a 3 cluster sheave. The next sheave was a single sheave.

The Columbia Load master was directing the crane and a single tag line was in use.

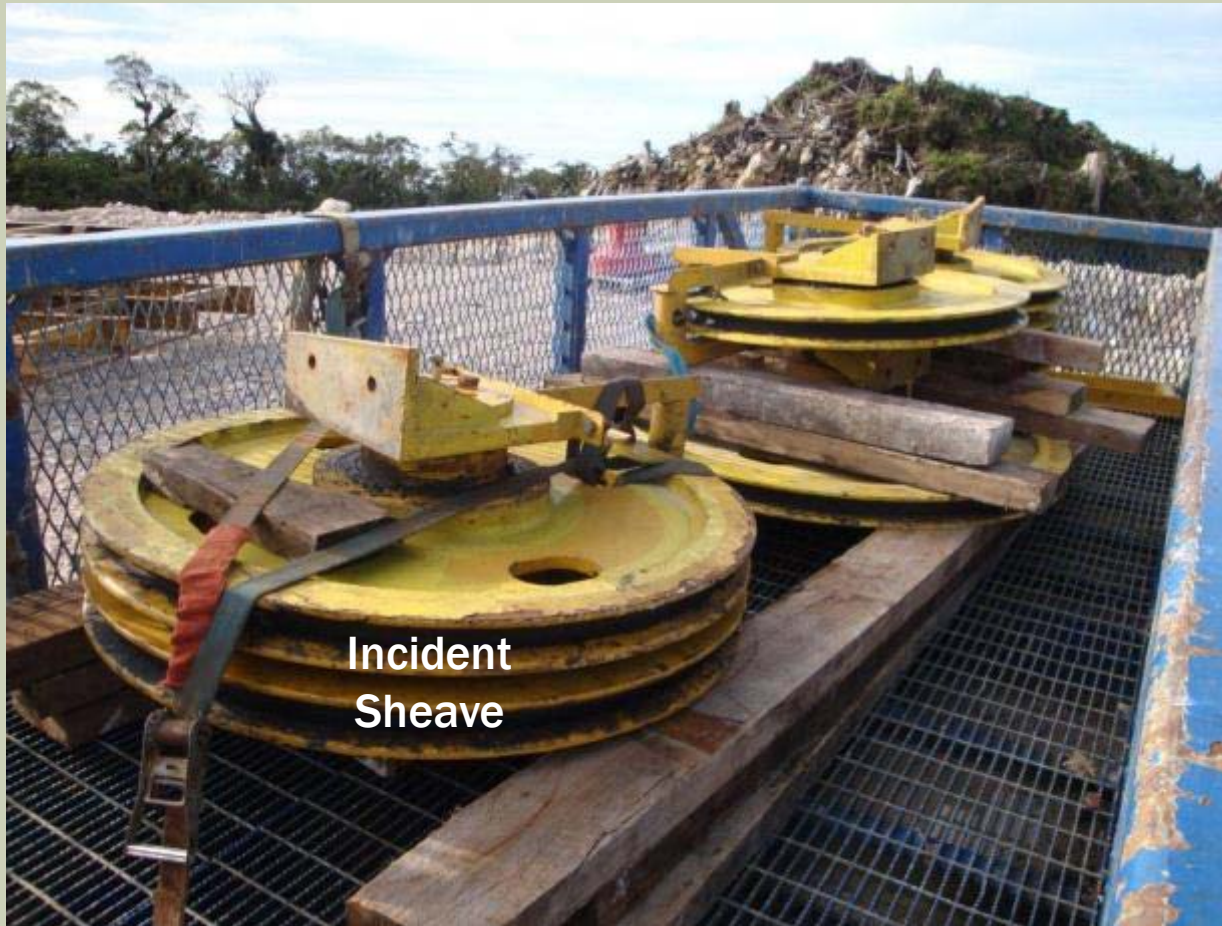
Incident
Sheave

The next sheave to be picked up was the 2 cluster sheave (the sheave causing the injury).

The sheave was still fitted with the line jumper bar, shaft and the bearing. A tag line was fitted but unlike the first two sheaves, only one soft sling was fitted to pick it up.

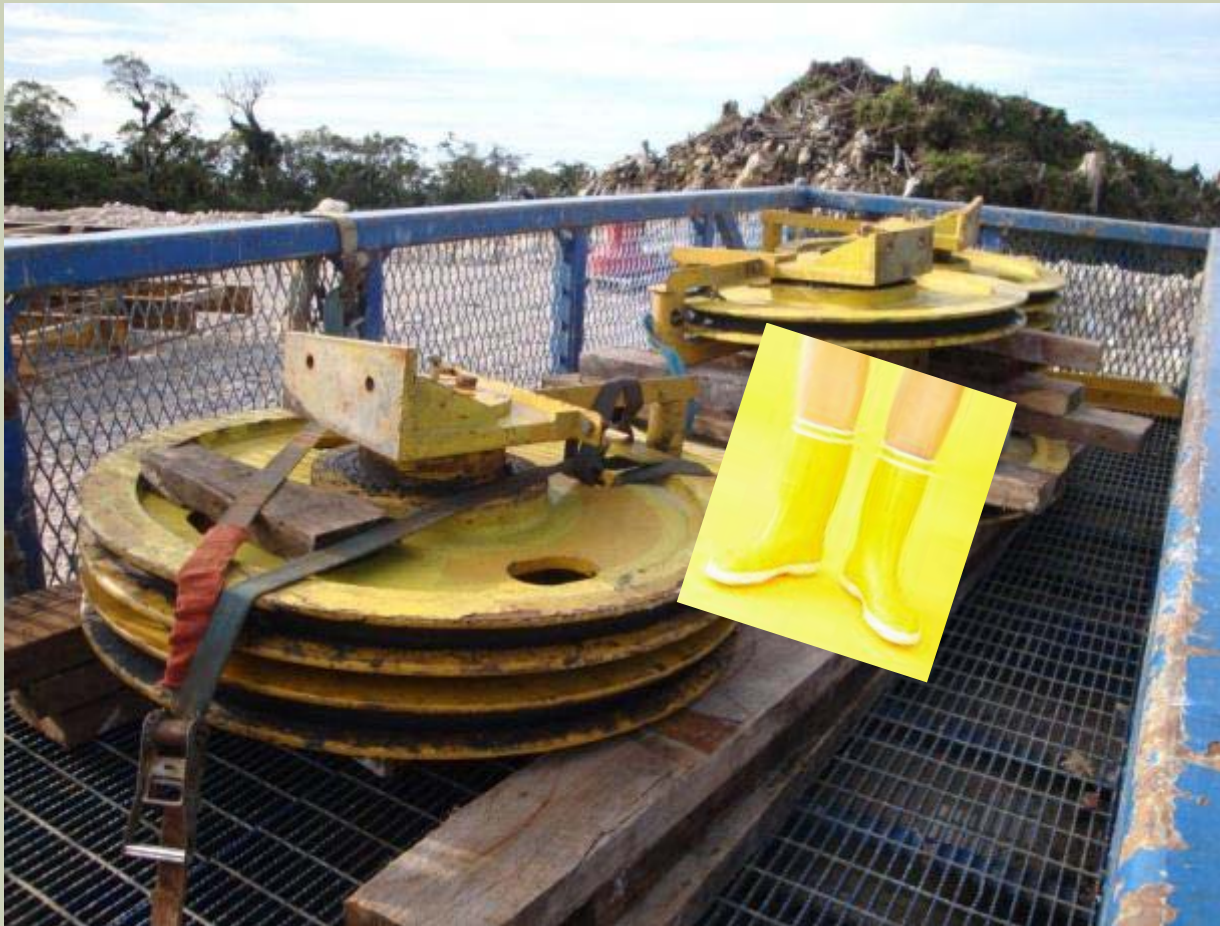
When the sheave was vertical inside the basket, the line bumper which was not as wide as the two positioned rows of DY, sat inside the boards resting on the basket grated bottom.

The Driller, was positioned between the vertical sheave and the sheaves already lowered on the DY.

His two legs straddle the right hand row of DY with his right leg inside between the two DY rows.

His two hands were on top of the sheaves so that he could guide the sheave as it was lowered.

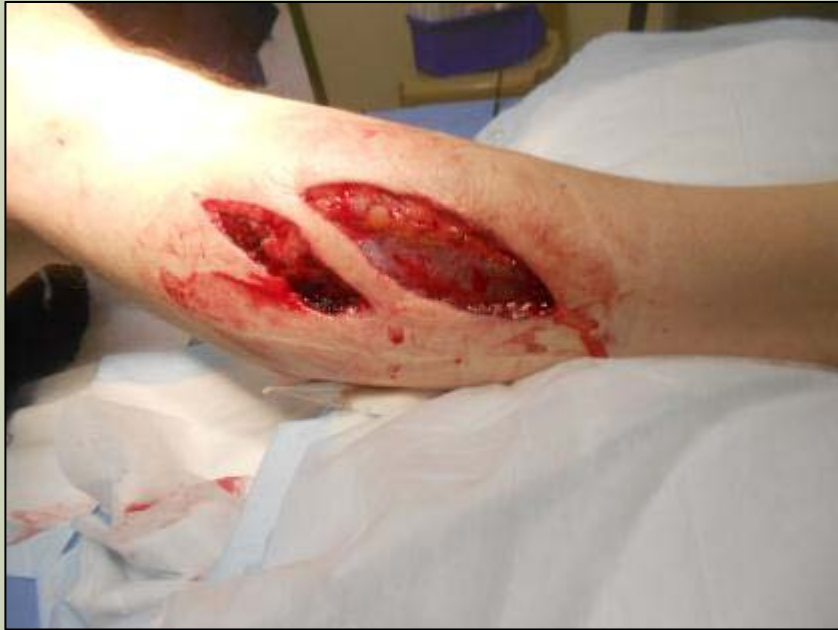
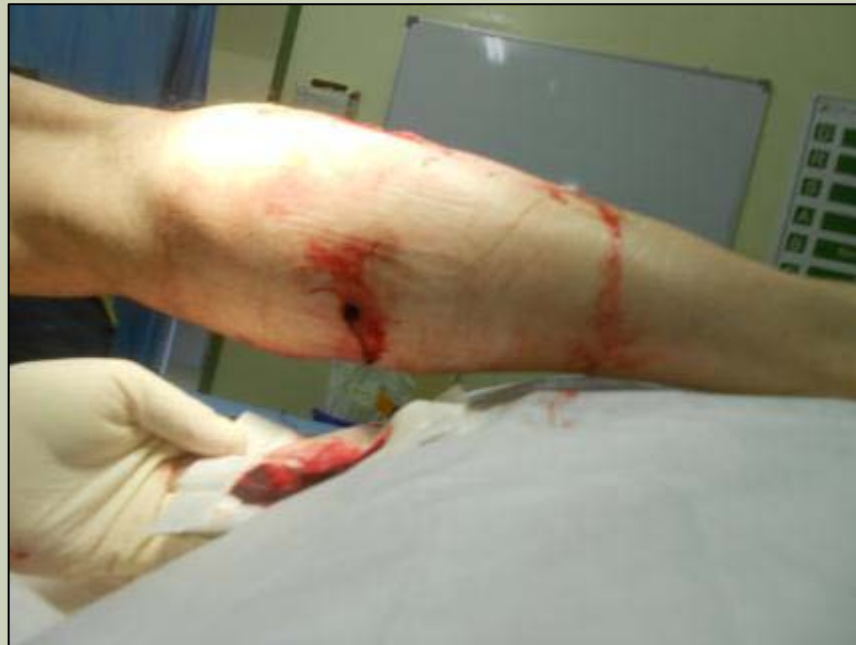
What happened next could not be fully determined other than the sheave turned and caught the Driller's right leg around his calf.

The resultant injury was a 7 cm laceration, a 5 cm laceration and the puncture wound. What actually caused the injuries was also not clearly determined other than it is likely it was the angle bracket and/associated fitted nuts and bolts on the sheave itself.

The crane operator saw the sheave turn towards the Driller and immediately picked up on the sheave to try to stop it hitting him.

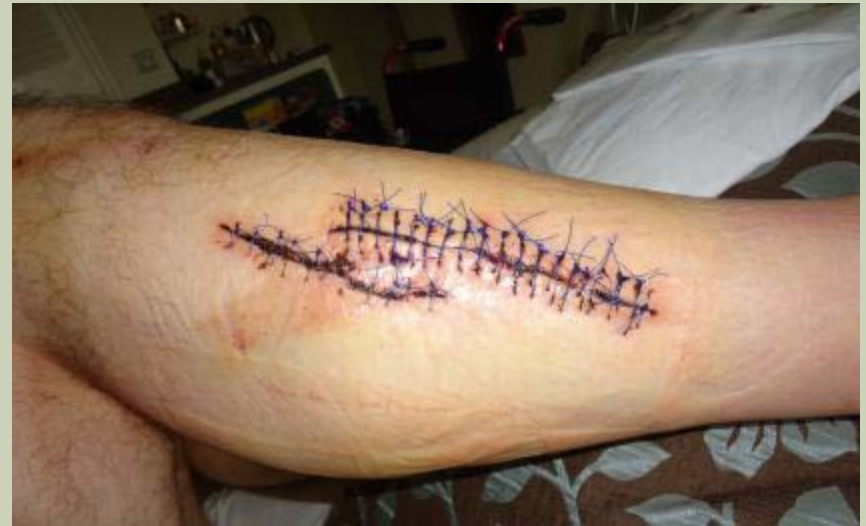
- Later that day IP was evacuated to Moro and onwards to Cairns Base Hospital for treatment.
- He spent 7 days in hospital and another 11 days in a Cairns hotel recovering before he could travel.
- HAES flew his wife from Canada to be with him.
- IP was cleared to travel on the 31st January. On advice from the treating doctor, the IP was given an injection to prevent DVT during his flight home.
- HAES arranged return business flights for IP and his wife. Both left the 1st February.
- IP return to work on his normal shift 4 weeks later. No problems encountered to date.
- Full investigation was completed. Corrective actions were put in place to prevent any reoccurrence.

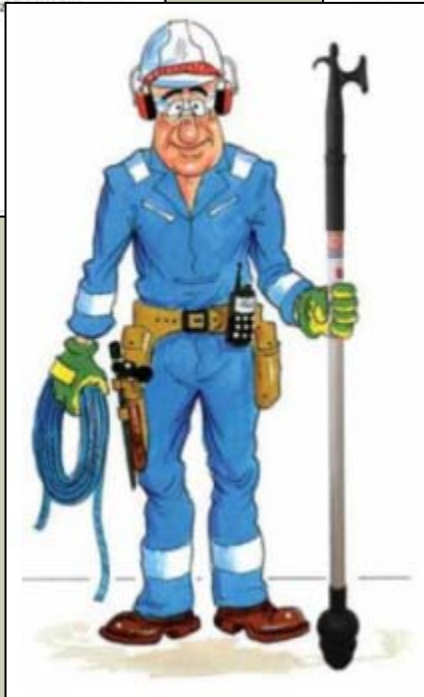
2 x Push / Pull rods distributed to all locations
