Repeating a High Potential Incident

James Peyton
March 2013

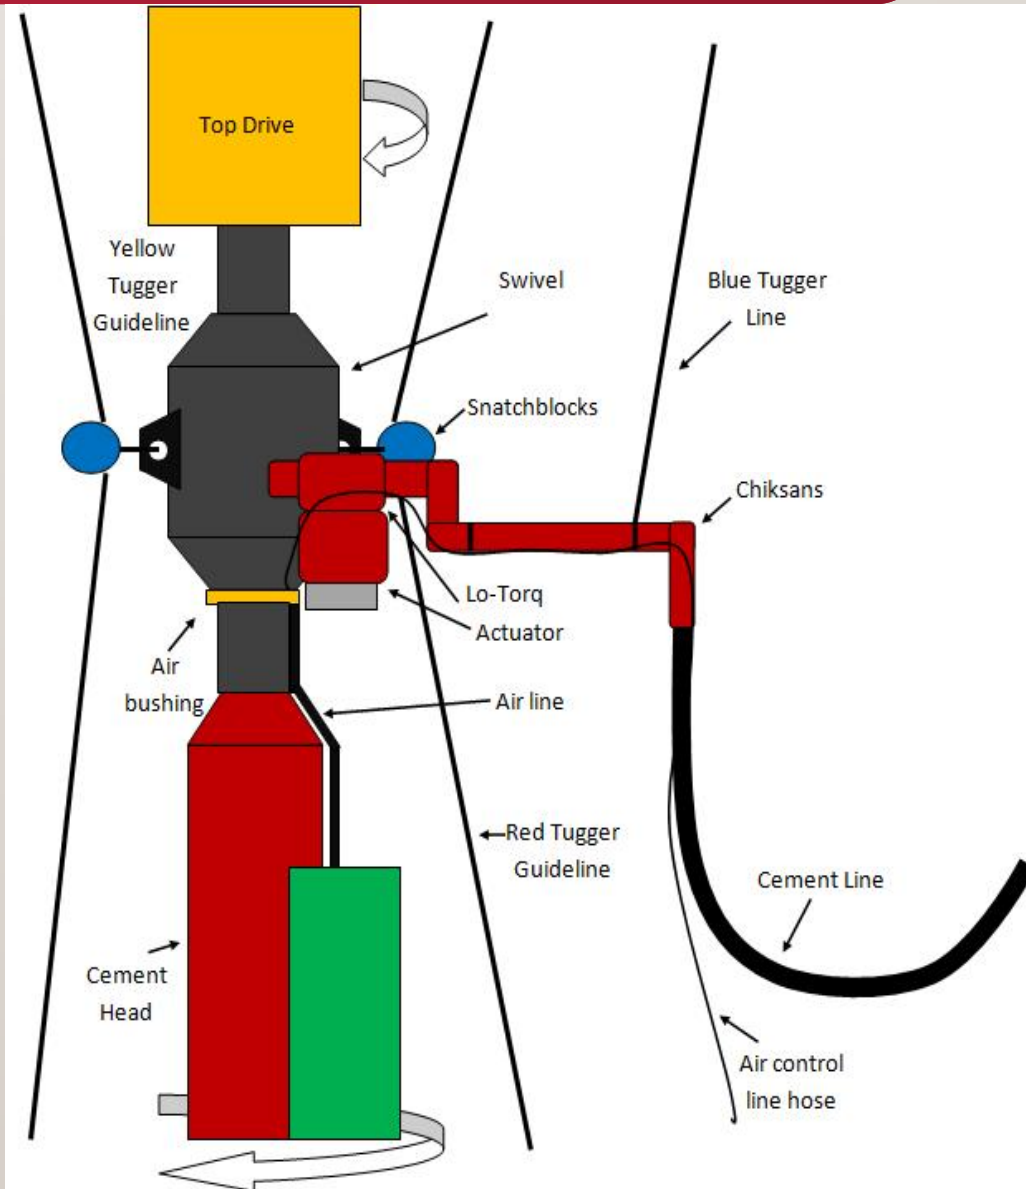
Top Drive Cement Head

- § Made up below Top Drive to landing string
- § Enables cement darts to be launched
- § Remotely actuated valves to reduce man-riding
- § Enables rotation of workstring and casing during cement job
- § Rotating during a cement job improves annular cement quality
