Atwood Eagle

Crushed Finger – 14th October 2006

Crushed Finger Incident Summary

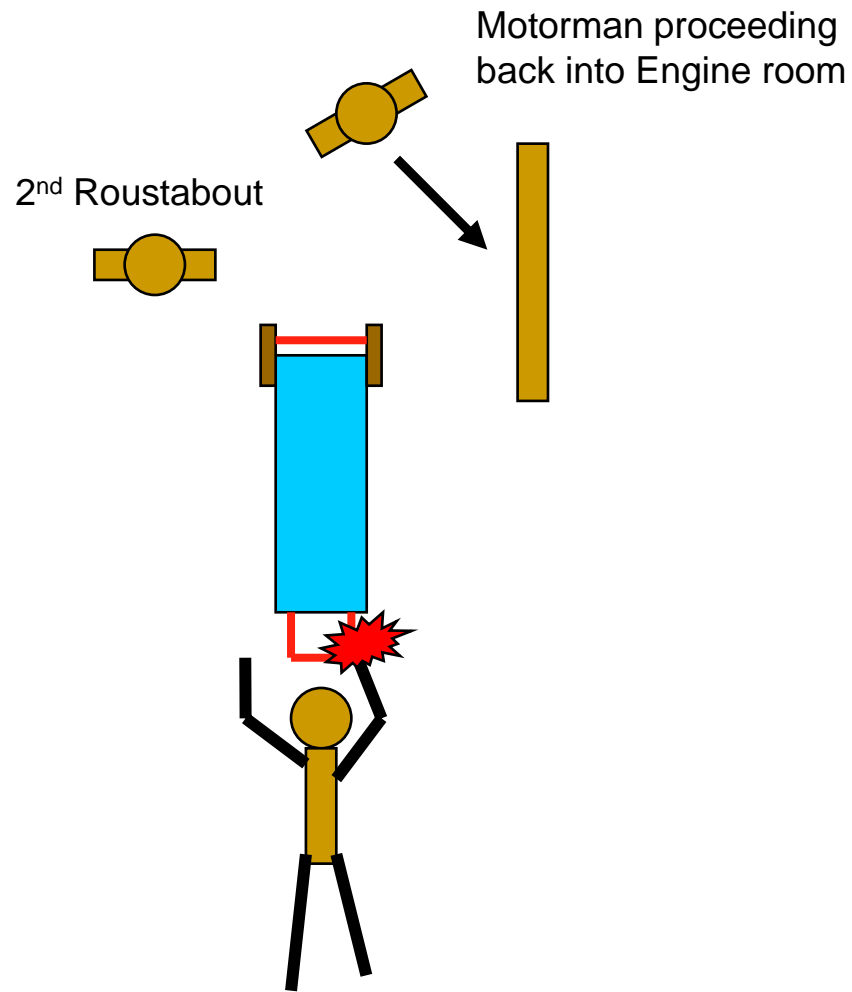
Top View of Incident

- With the power pack and trolley now outside the engine room, a roustabout (IP) promptly took hold of the trolley and lifted the power pack back on the trolley
 - At this point the IP was unable to control the load and it continued coming down past the point of equilibrium
 - The IP attempted to catch the load and prevent it from falling and in doing so caught his right hand little finger between the trolley handle and deck resulting in a compound fracture
-

- Install mechanical lifting / trolley securing arrangement for this task
- Conduct hazard hunt across rig to identify areas where mechanical lifting points are required
- Develop a JSA for handling power packs and other similar activities as identified from the hazard hunt
- Educate crew on the suitability of various trolleys and hand safety
